Farmersville ADA Compliance and Active Transportation Safety Plan

City of Farmersville

Final

November 2019

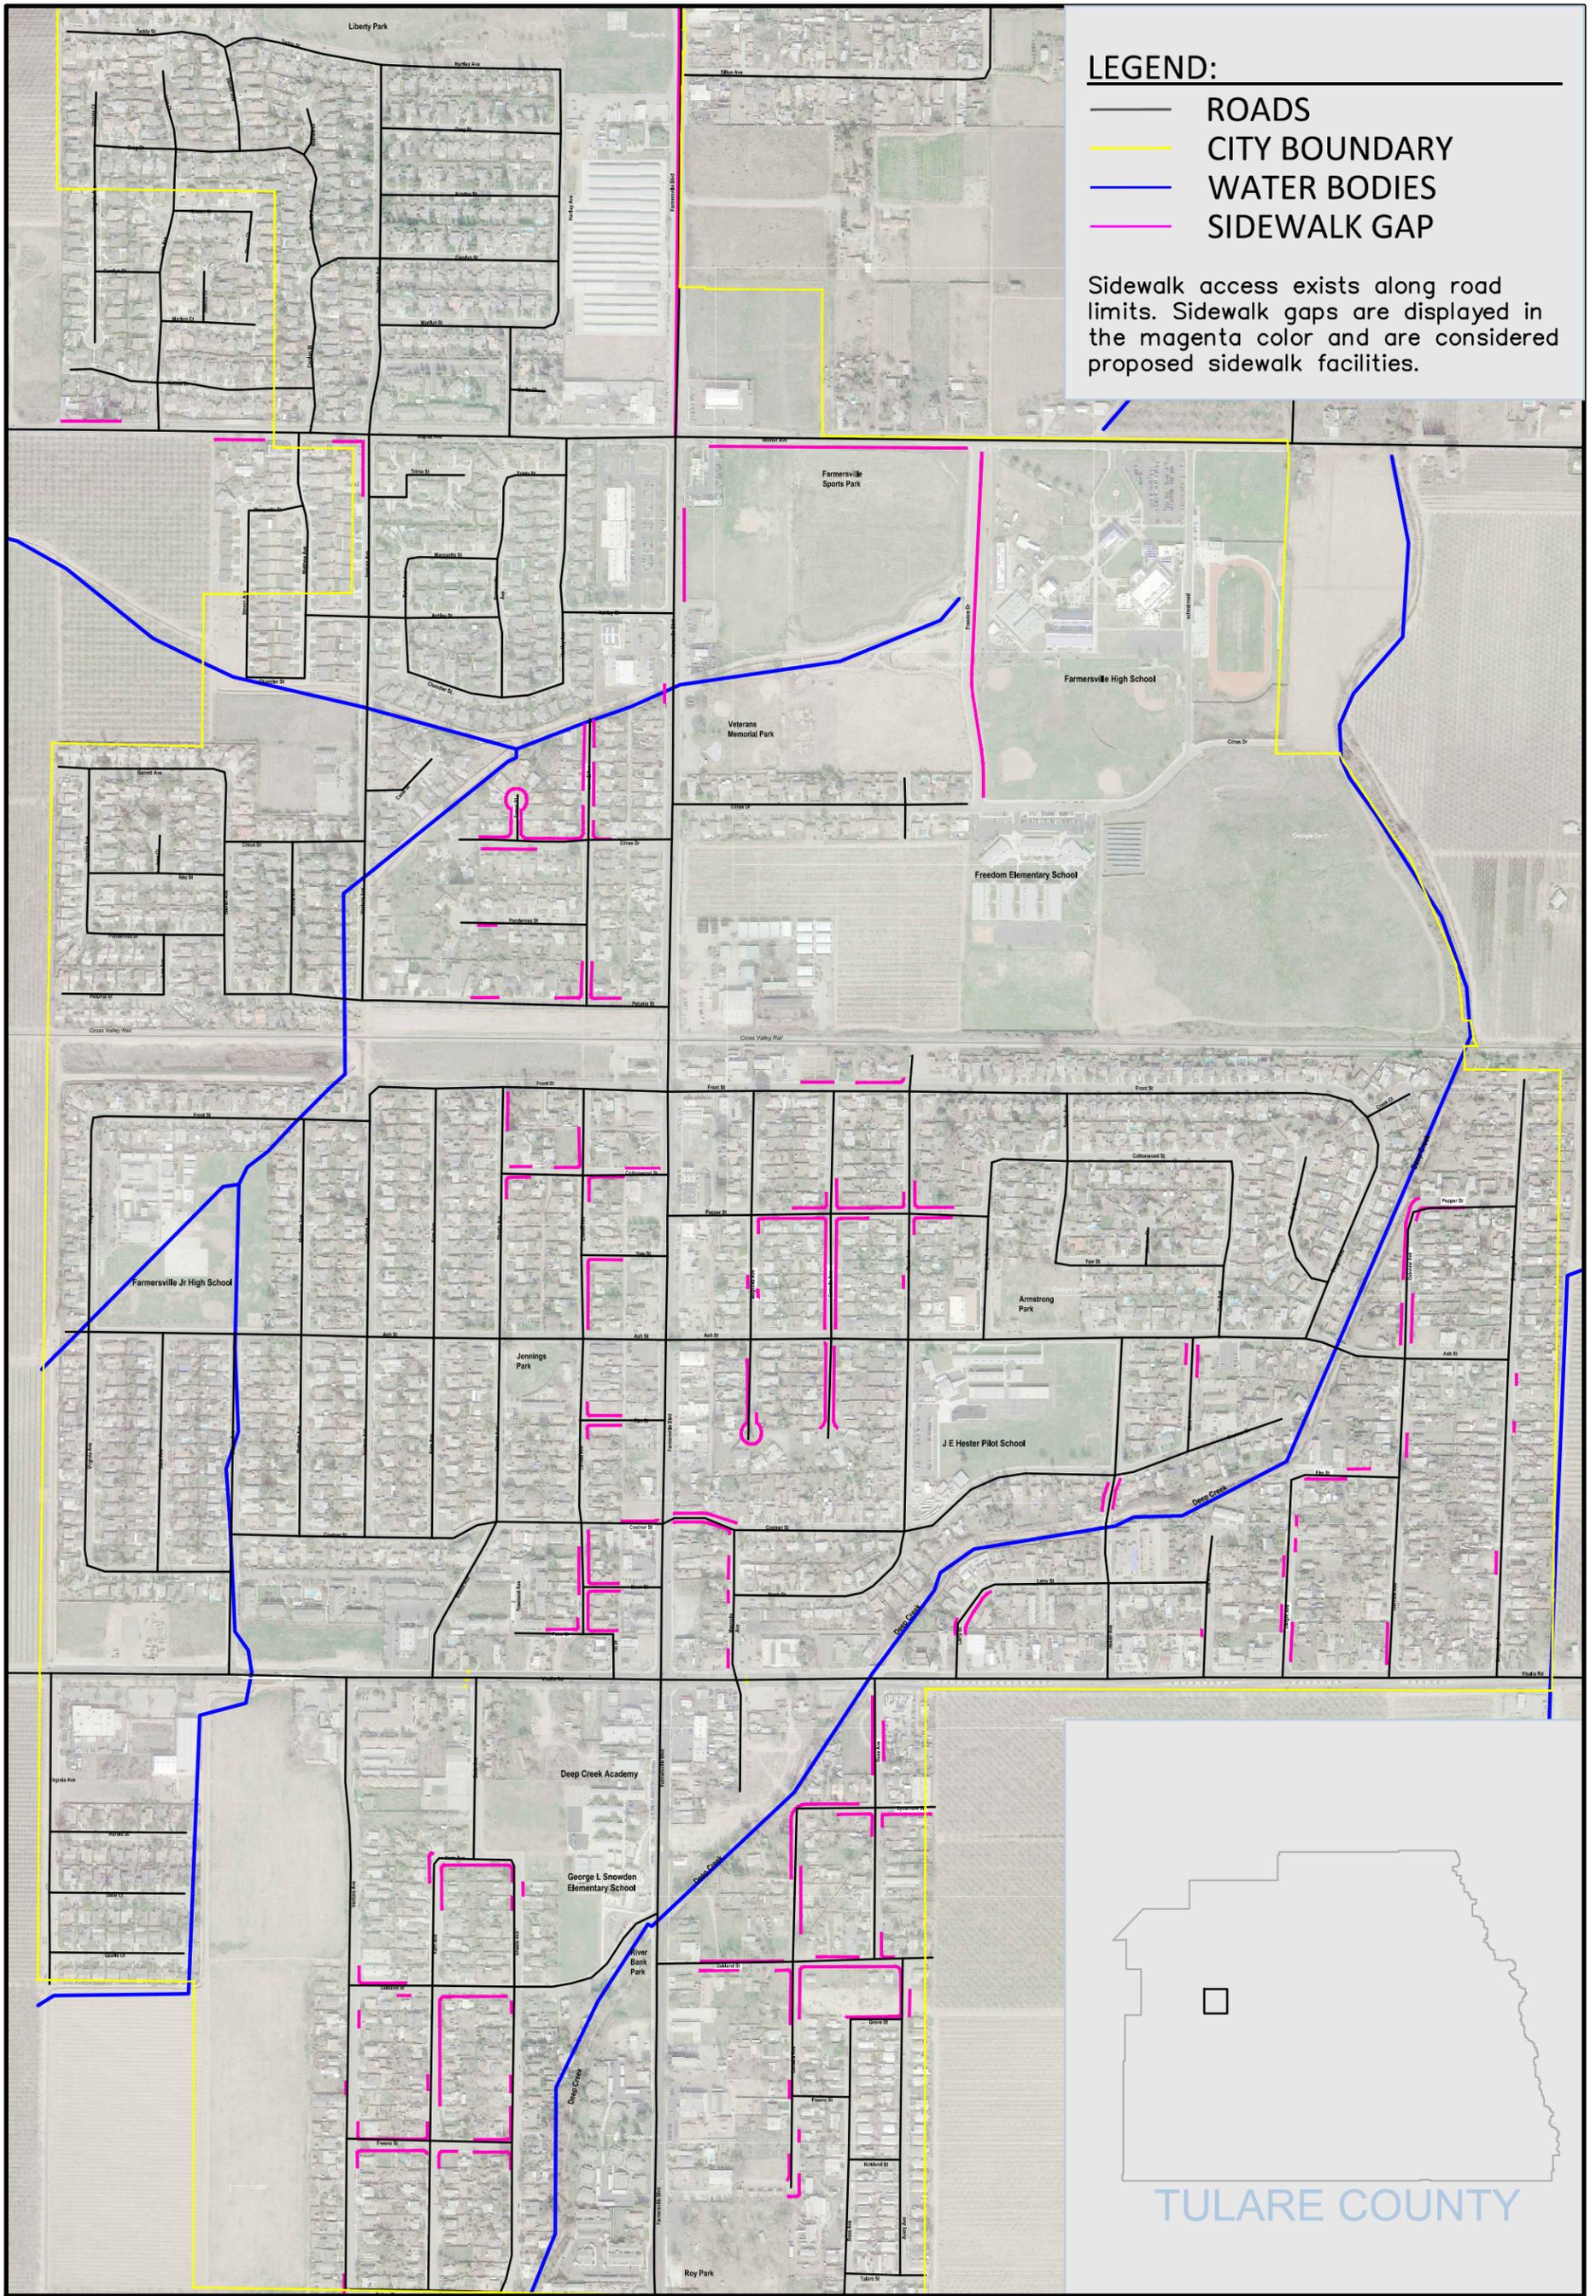
FIGURE 1-2
 Source: GHD 2019, Google Earth

- ROADS
- CITY BOUNDARY
- WATER BODIES
- SIDEWALK GAP

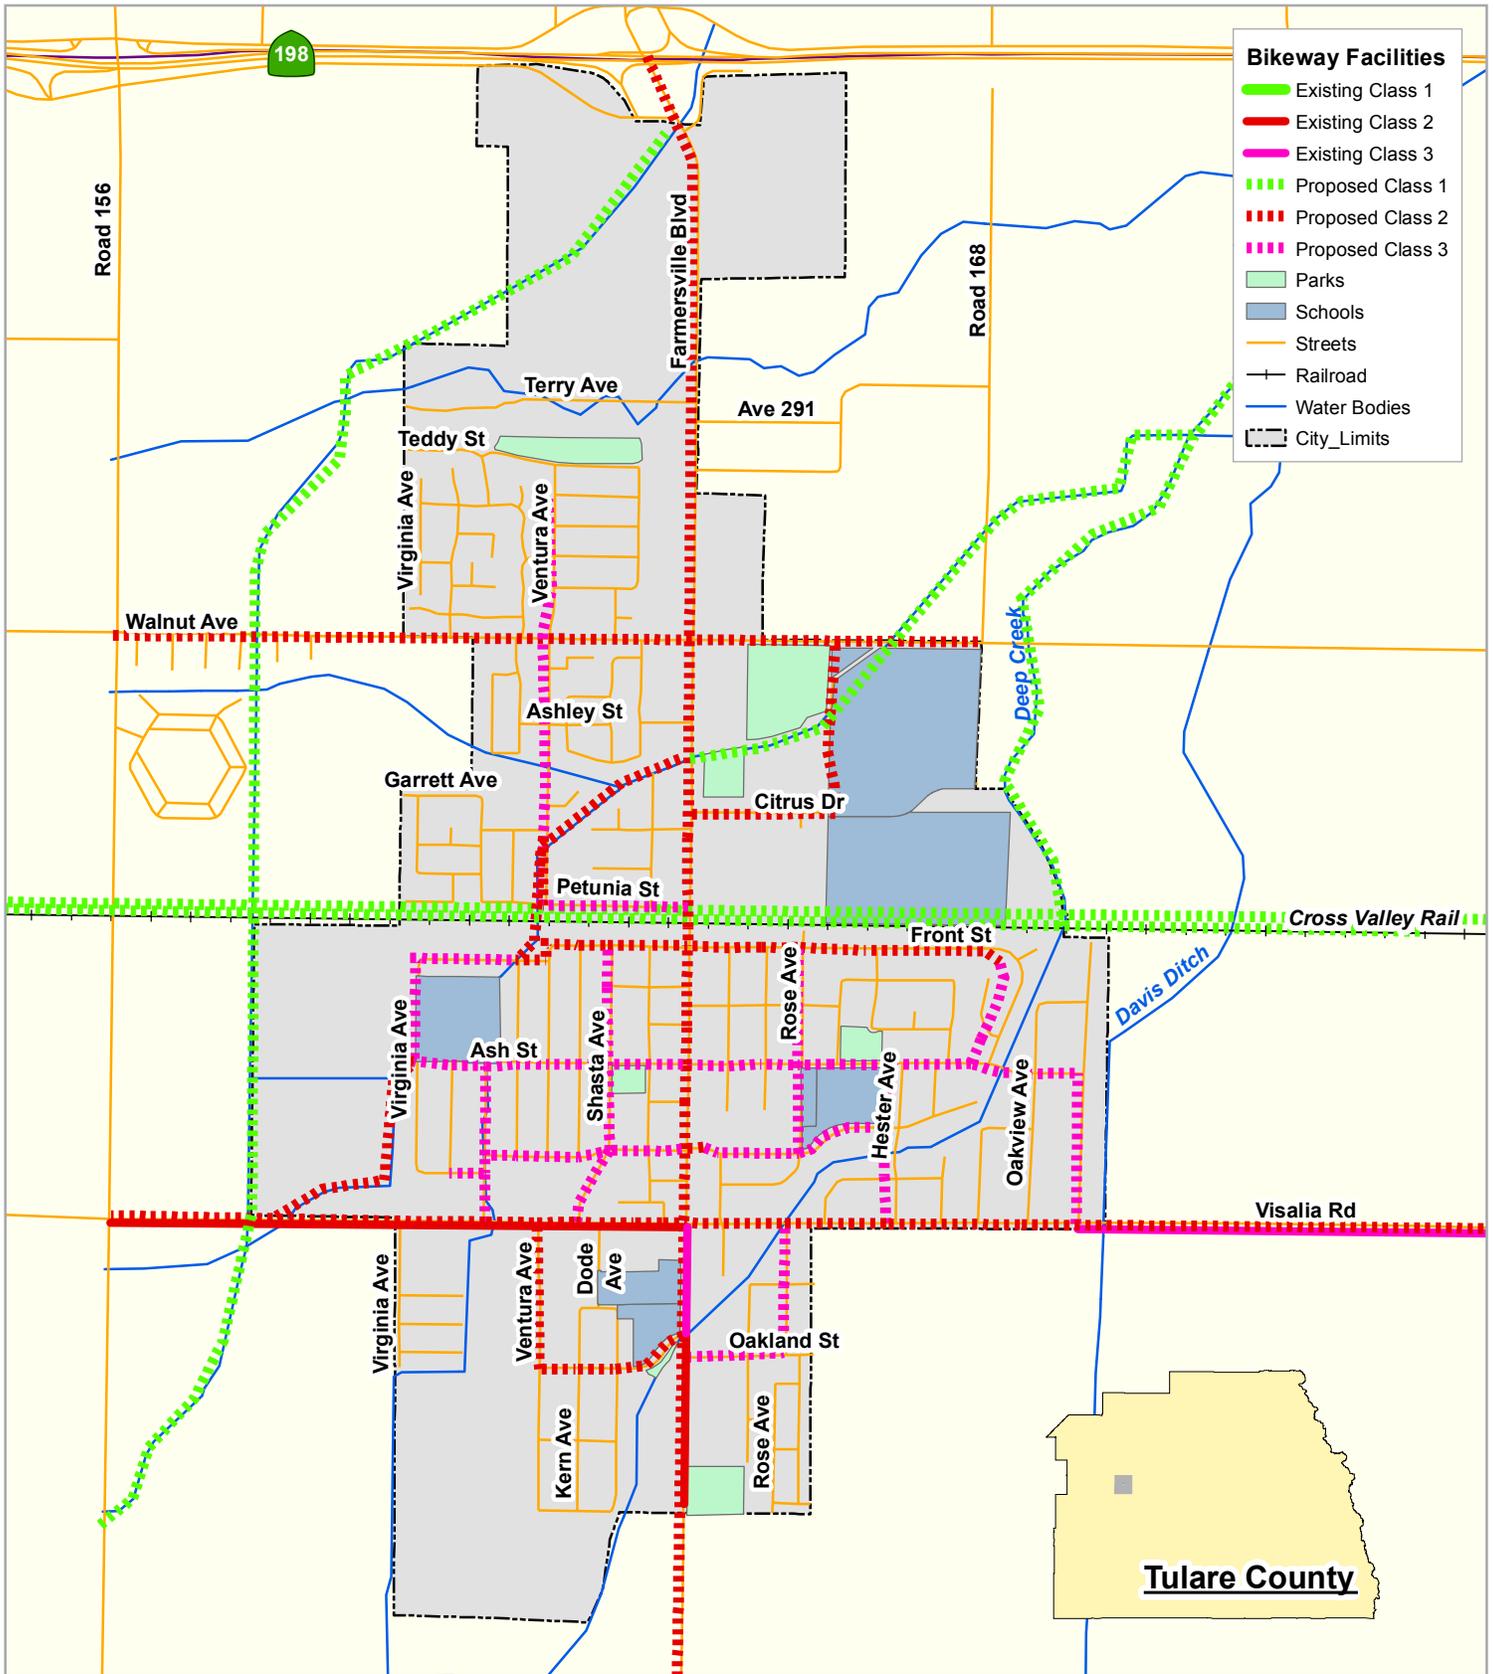
FIGURE 1-3

As shown in Figure 1-3, Class 1, 2, and 3 bicycle facilities are planned on arterials, collectors, and local streets. Several types of bikeway project are summarized below.

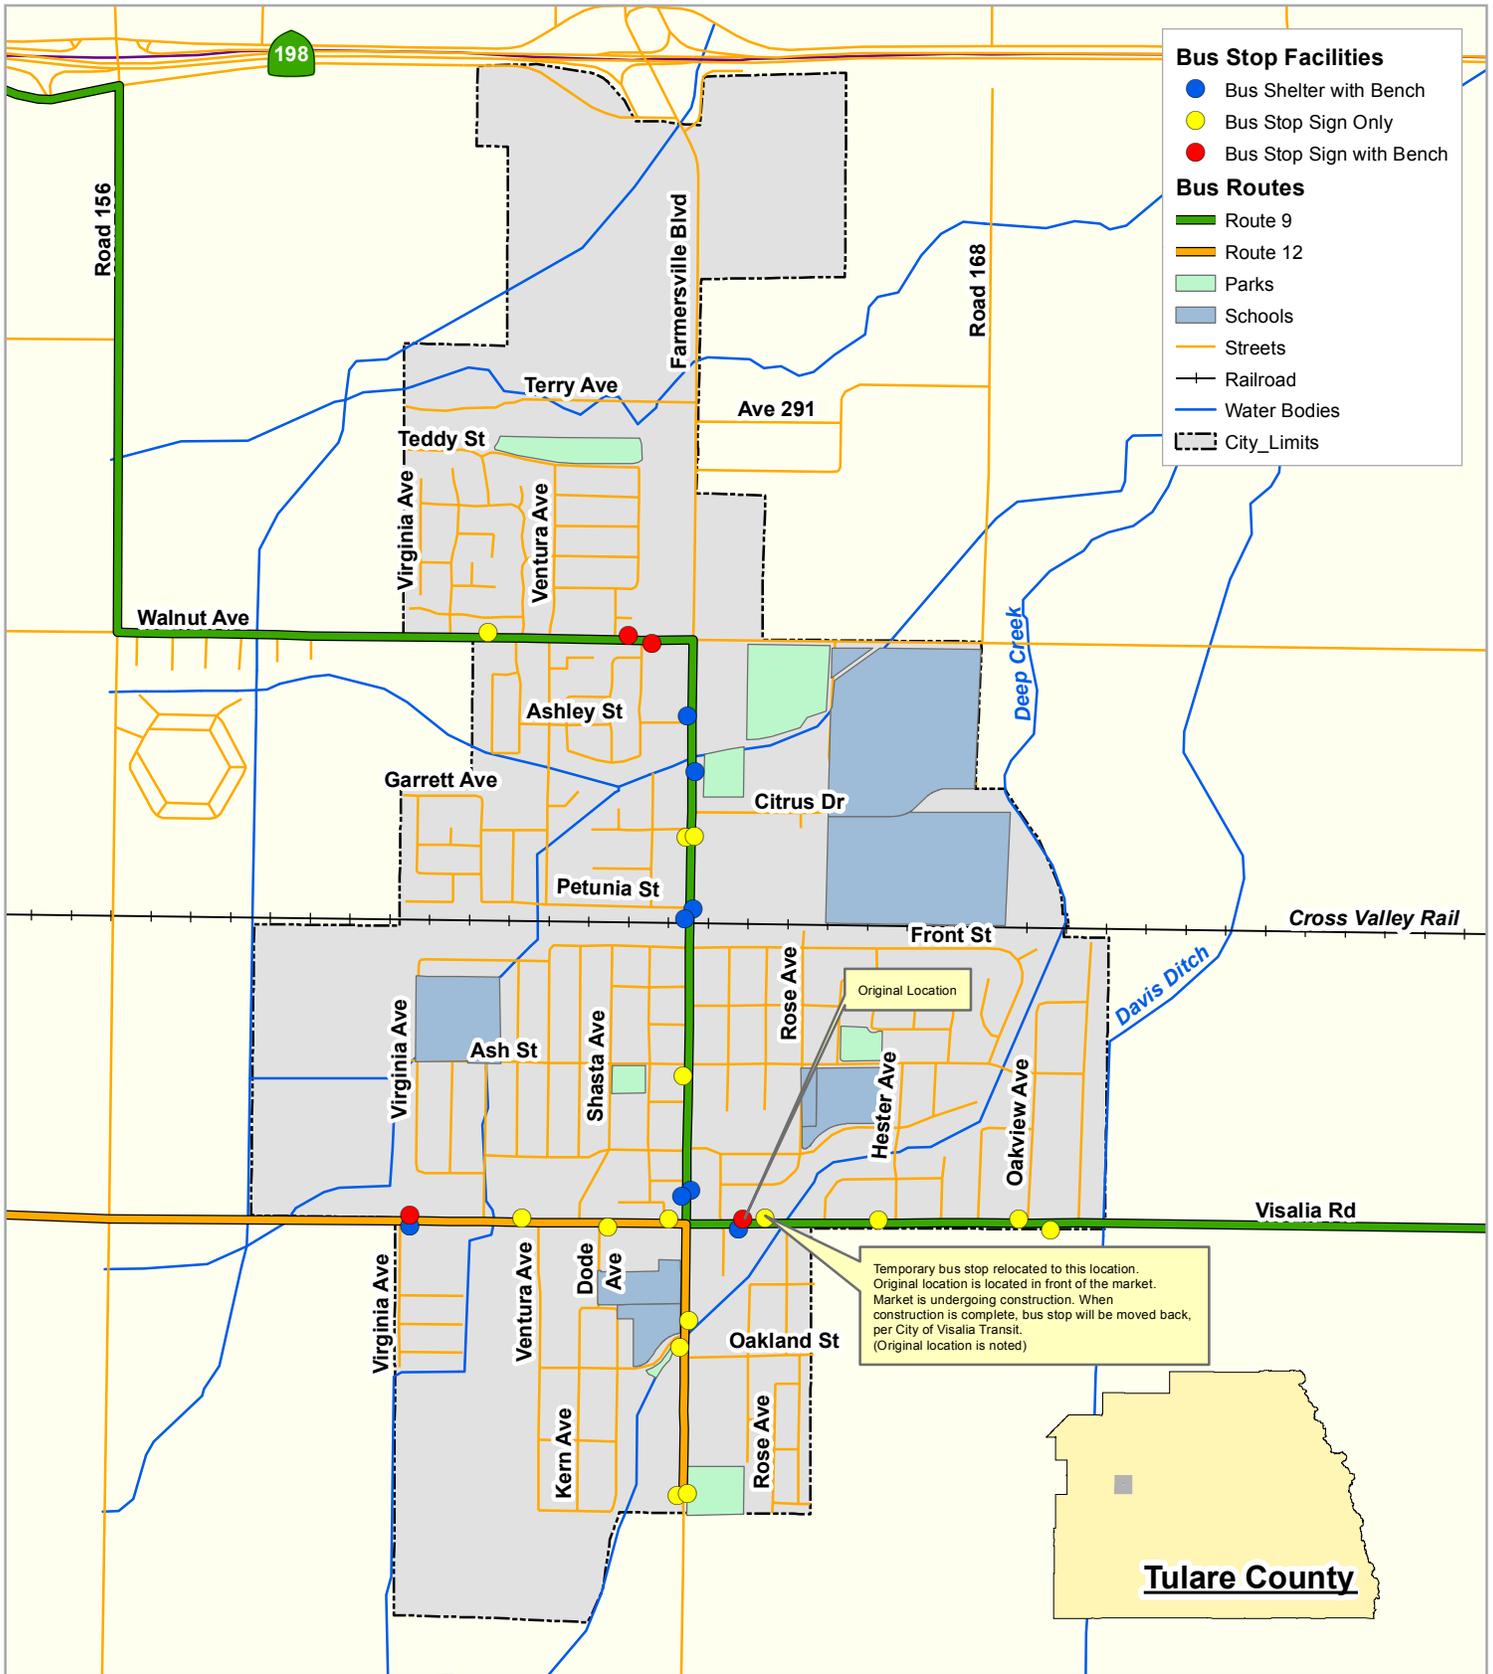
FIGURE 1-4

On Figure 1-4, bus stops on Route 9 (green) are shown below throughout the Farmersville area, as shown by screenshot from Visalia Transit's web-based live map. Currently, 17 bus stops are found along Route 9 in Farmersville.

Bus stops on Route 12 (orange) are shown throughout the Farmersville area, as shown by screenshot from Visalia Transit's web-based live map. Ten (10) bus stops are found along Route 12 in Farmersville. On Visalia Road east of Farmersville Boulevard, bus stops are used for both Routes 9 and 12.

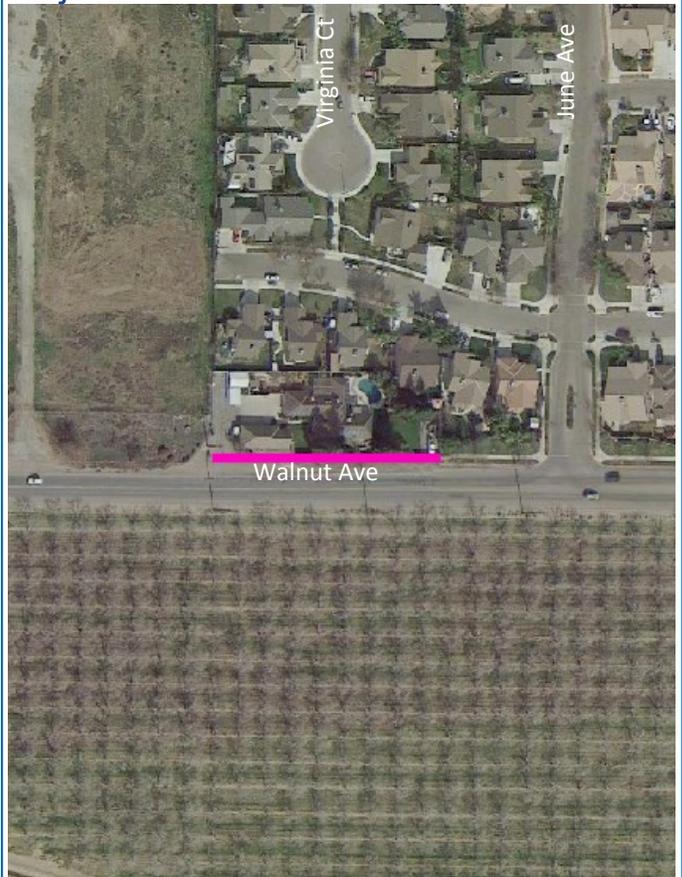
Project Illustration

- Partial segments of curb/gutter and sidewalk facilities.
- Missing segment of curb/gutter and sidewalk are shown in the Project Illustration.
- Approx. 255 ft. of sidewalk and curb/gutter needed.
- There is striping and markings on the road that include:
 - ⇒ Limit lines: End of most roadways stops.
 - ⇒ Nearest crosswalk: June Ave/Anissa Ct.
 - ⇒ Nearest markings: "Signal Ahead" - Walnut Ave/Hartley Ave.
- Nearest pedestrian signals: At the signalized intersection of Farmersville Blvd/Walnut Ave.
- There are no bicycle lanes or shared used trails facilities.

- Missing segments of curb/gutter and sidewalk to connect/conform to the existing curb/gutter and sidewalk facility needed to have a fully functional curb/gutter and sidewalk.
- Missing segment of curb/gutter and sidewalk are to meet current ADA standards.
- Walnut Ave is proposed to have a Class 2 Bicycle Facility.

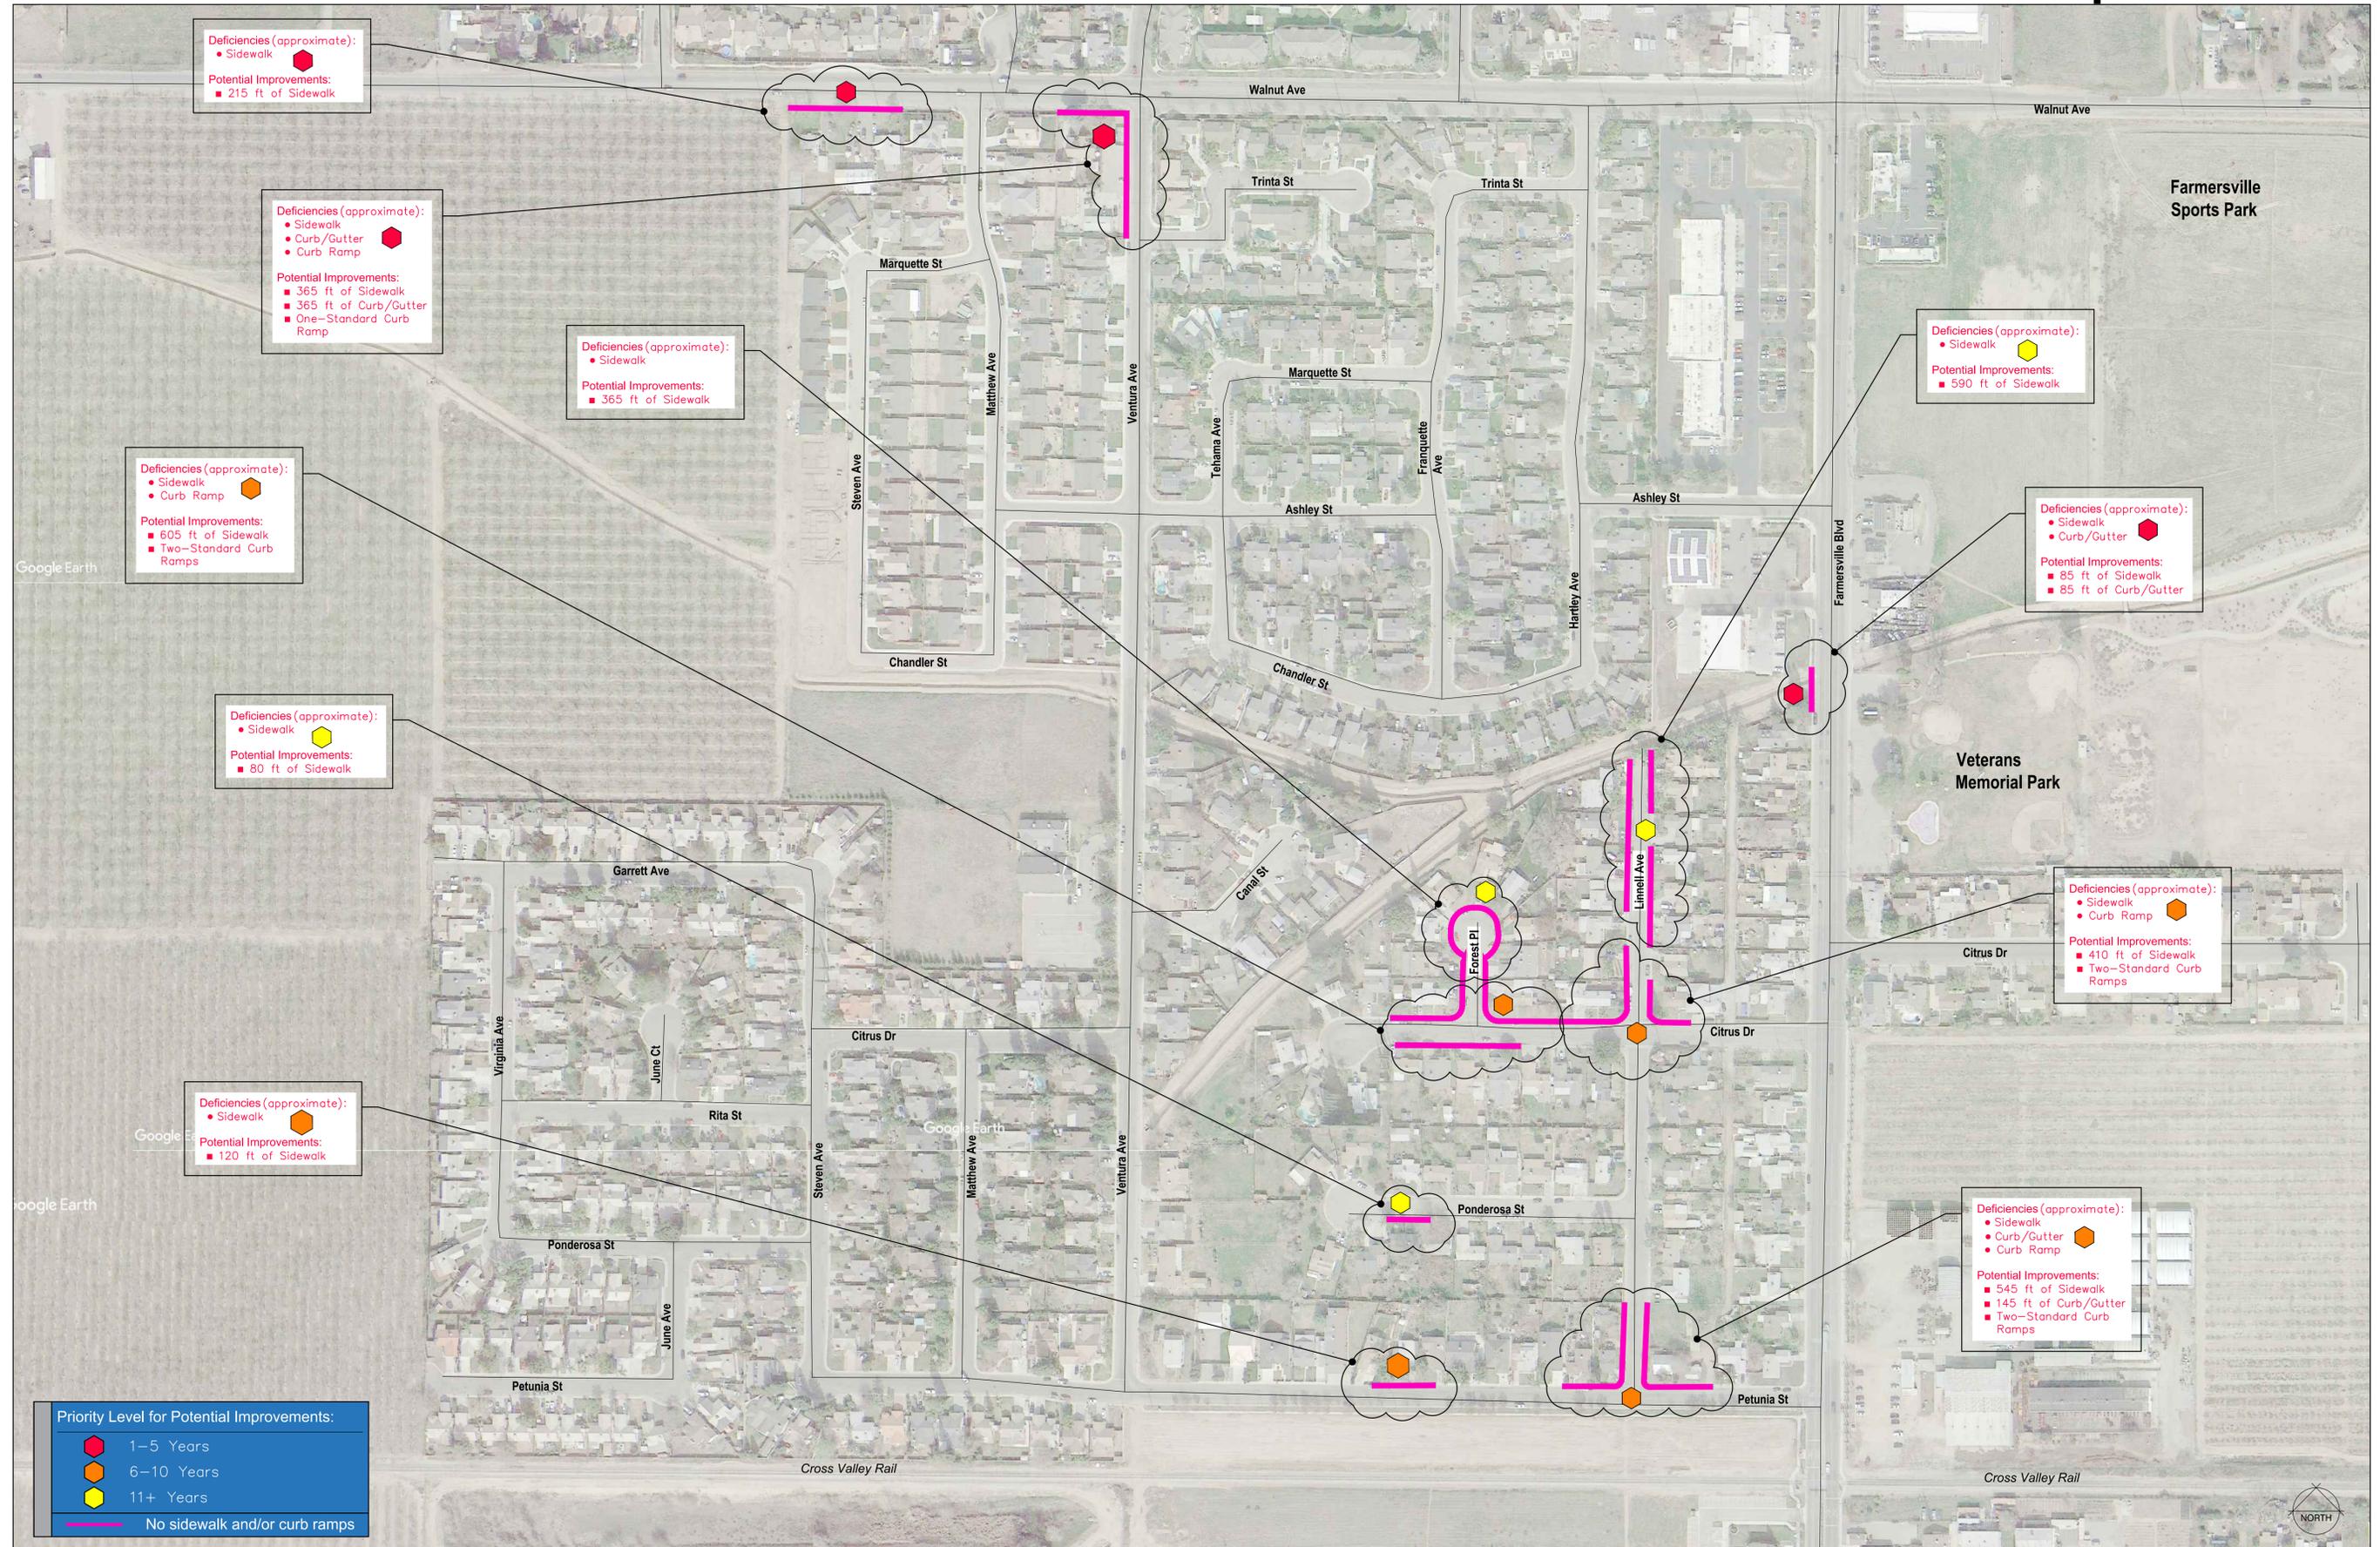
ADA Compliance and Active Transportation Safety Enhancement Plan **Figure 6-2B**

Sector B

ADA Deficiencies and Potential Improvements

In addition, Exhibits 6-2A thru 6-2F identify deficiencies and provide prioritization of potential based upon established criteria.

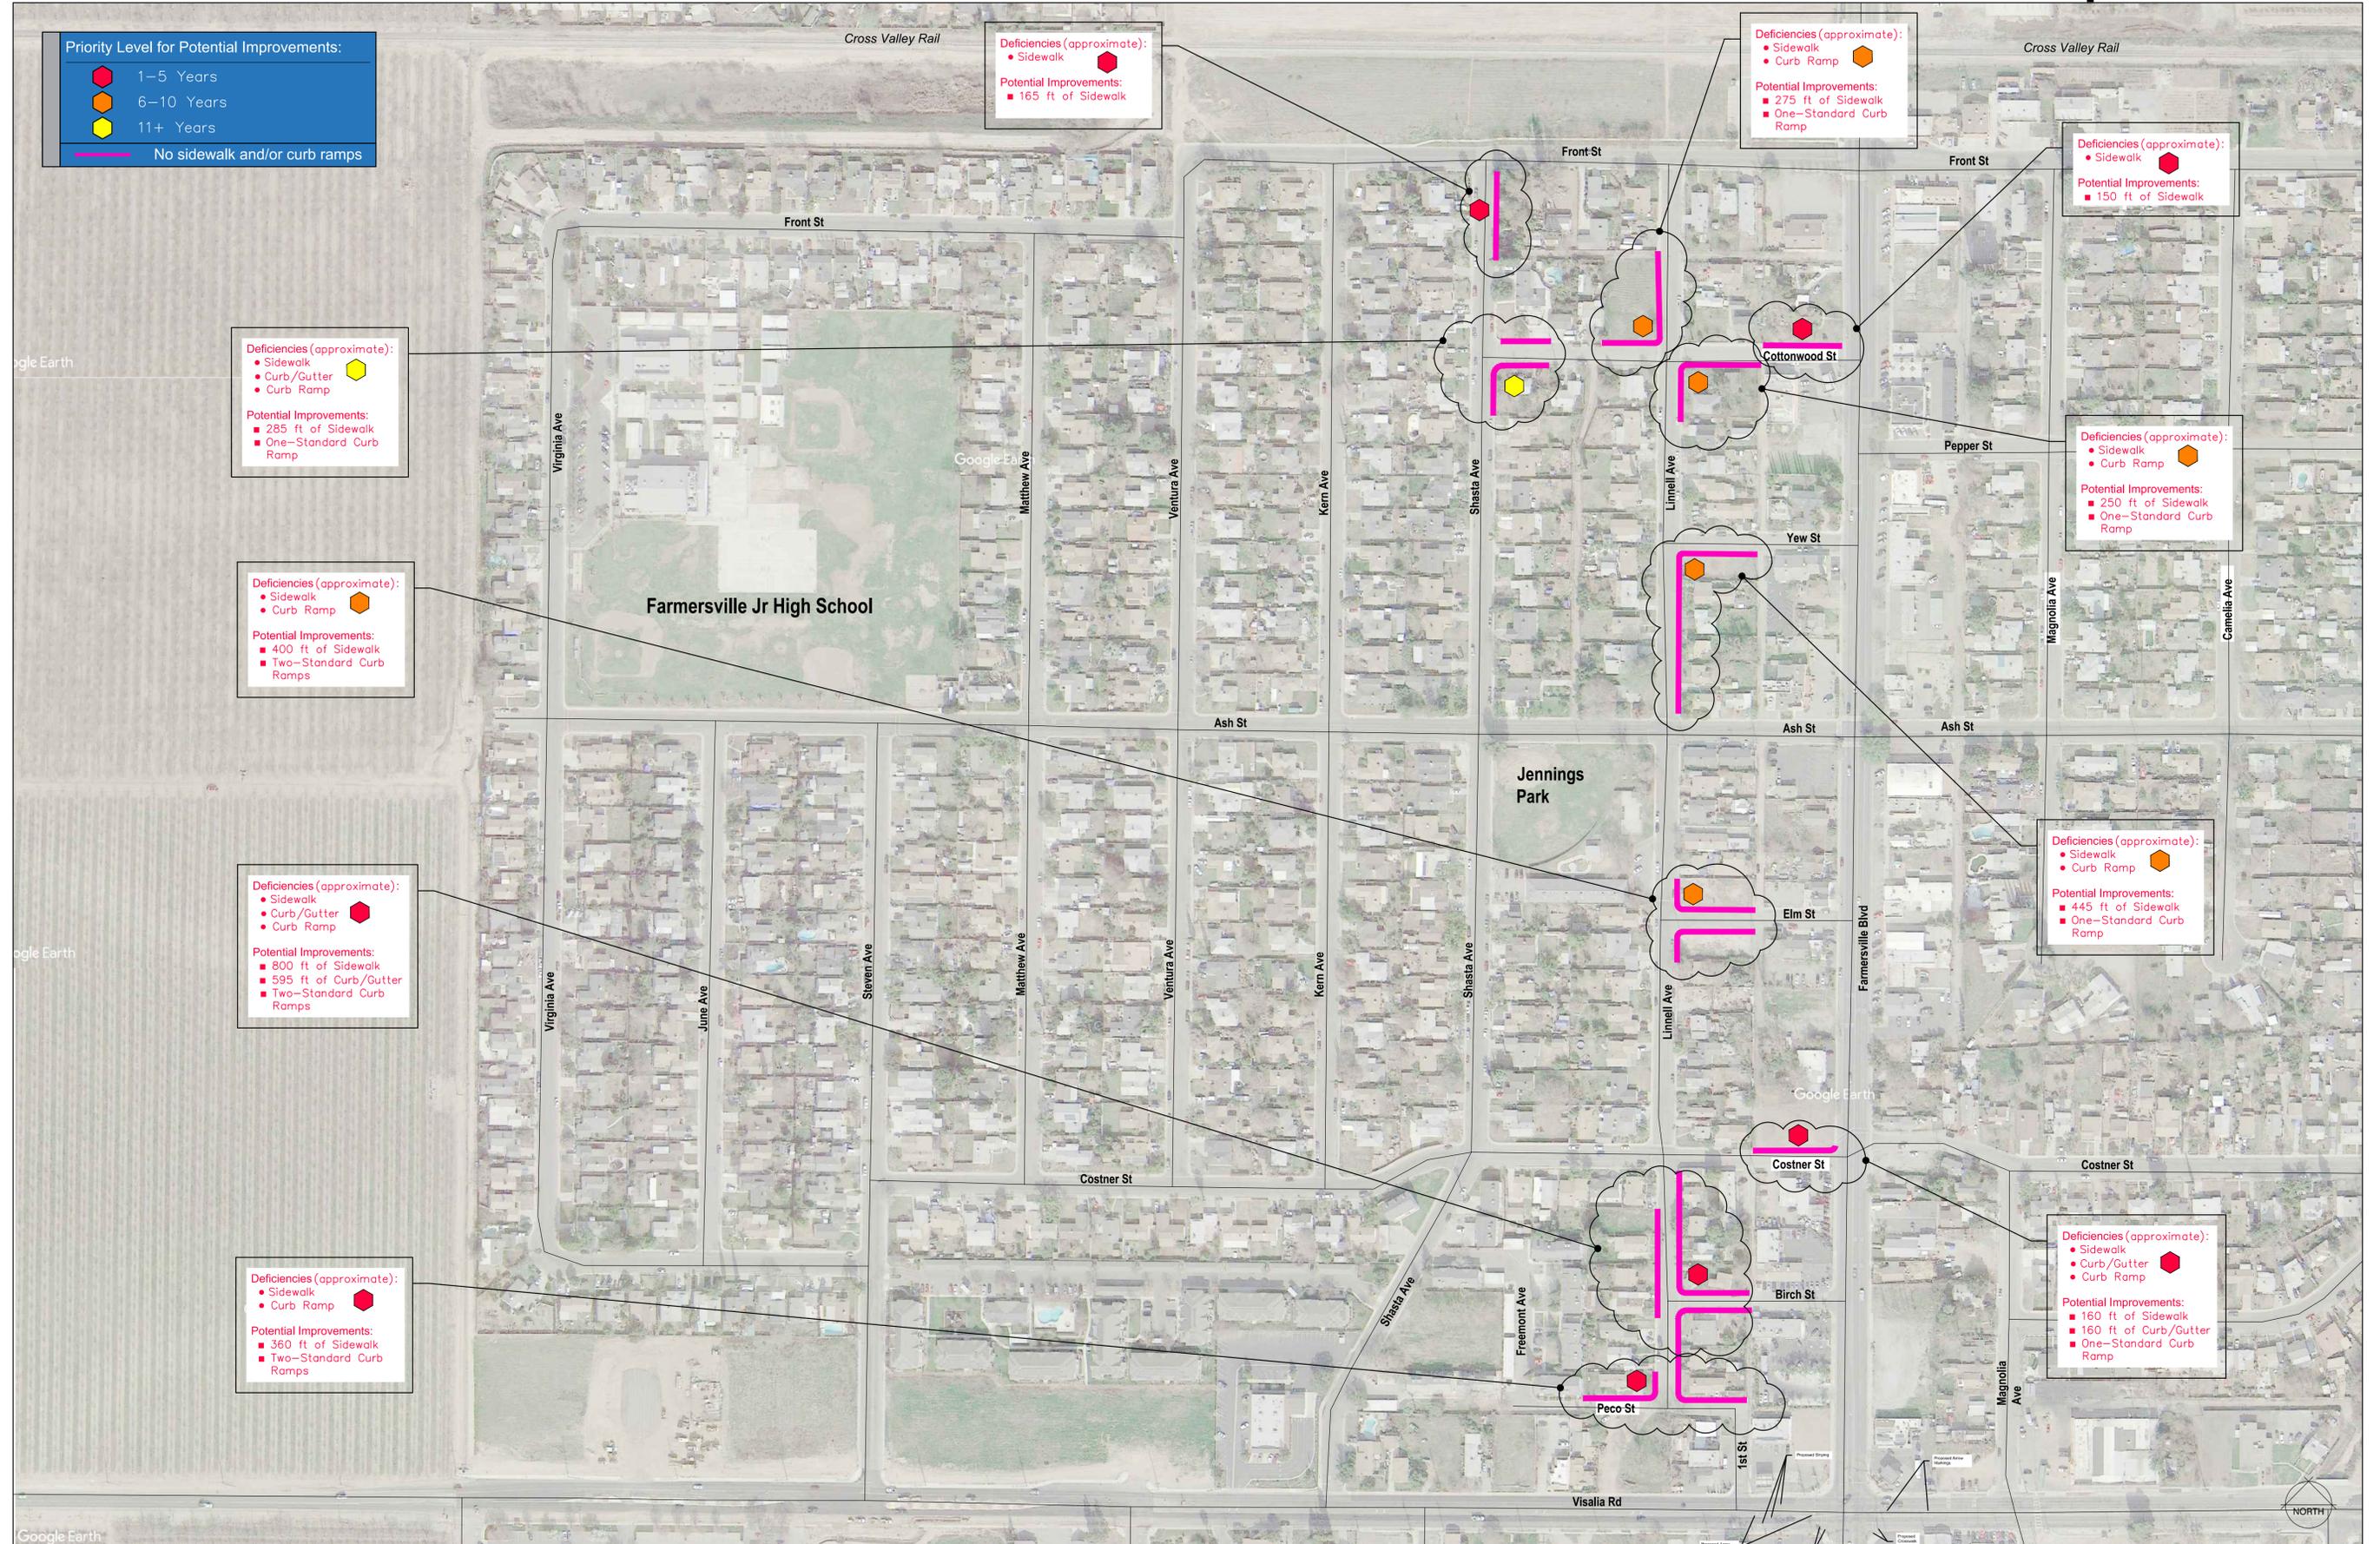
Figure 6-2D

Sector D

ADA Deficiencies and Potential Improvements

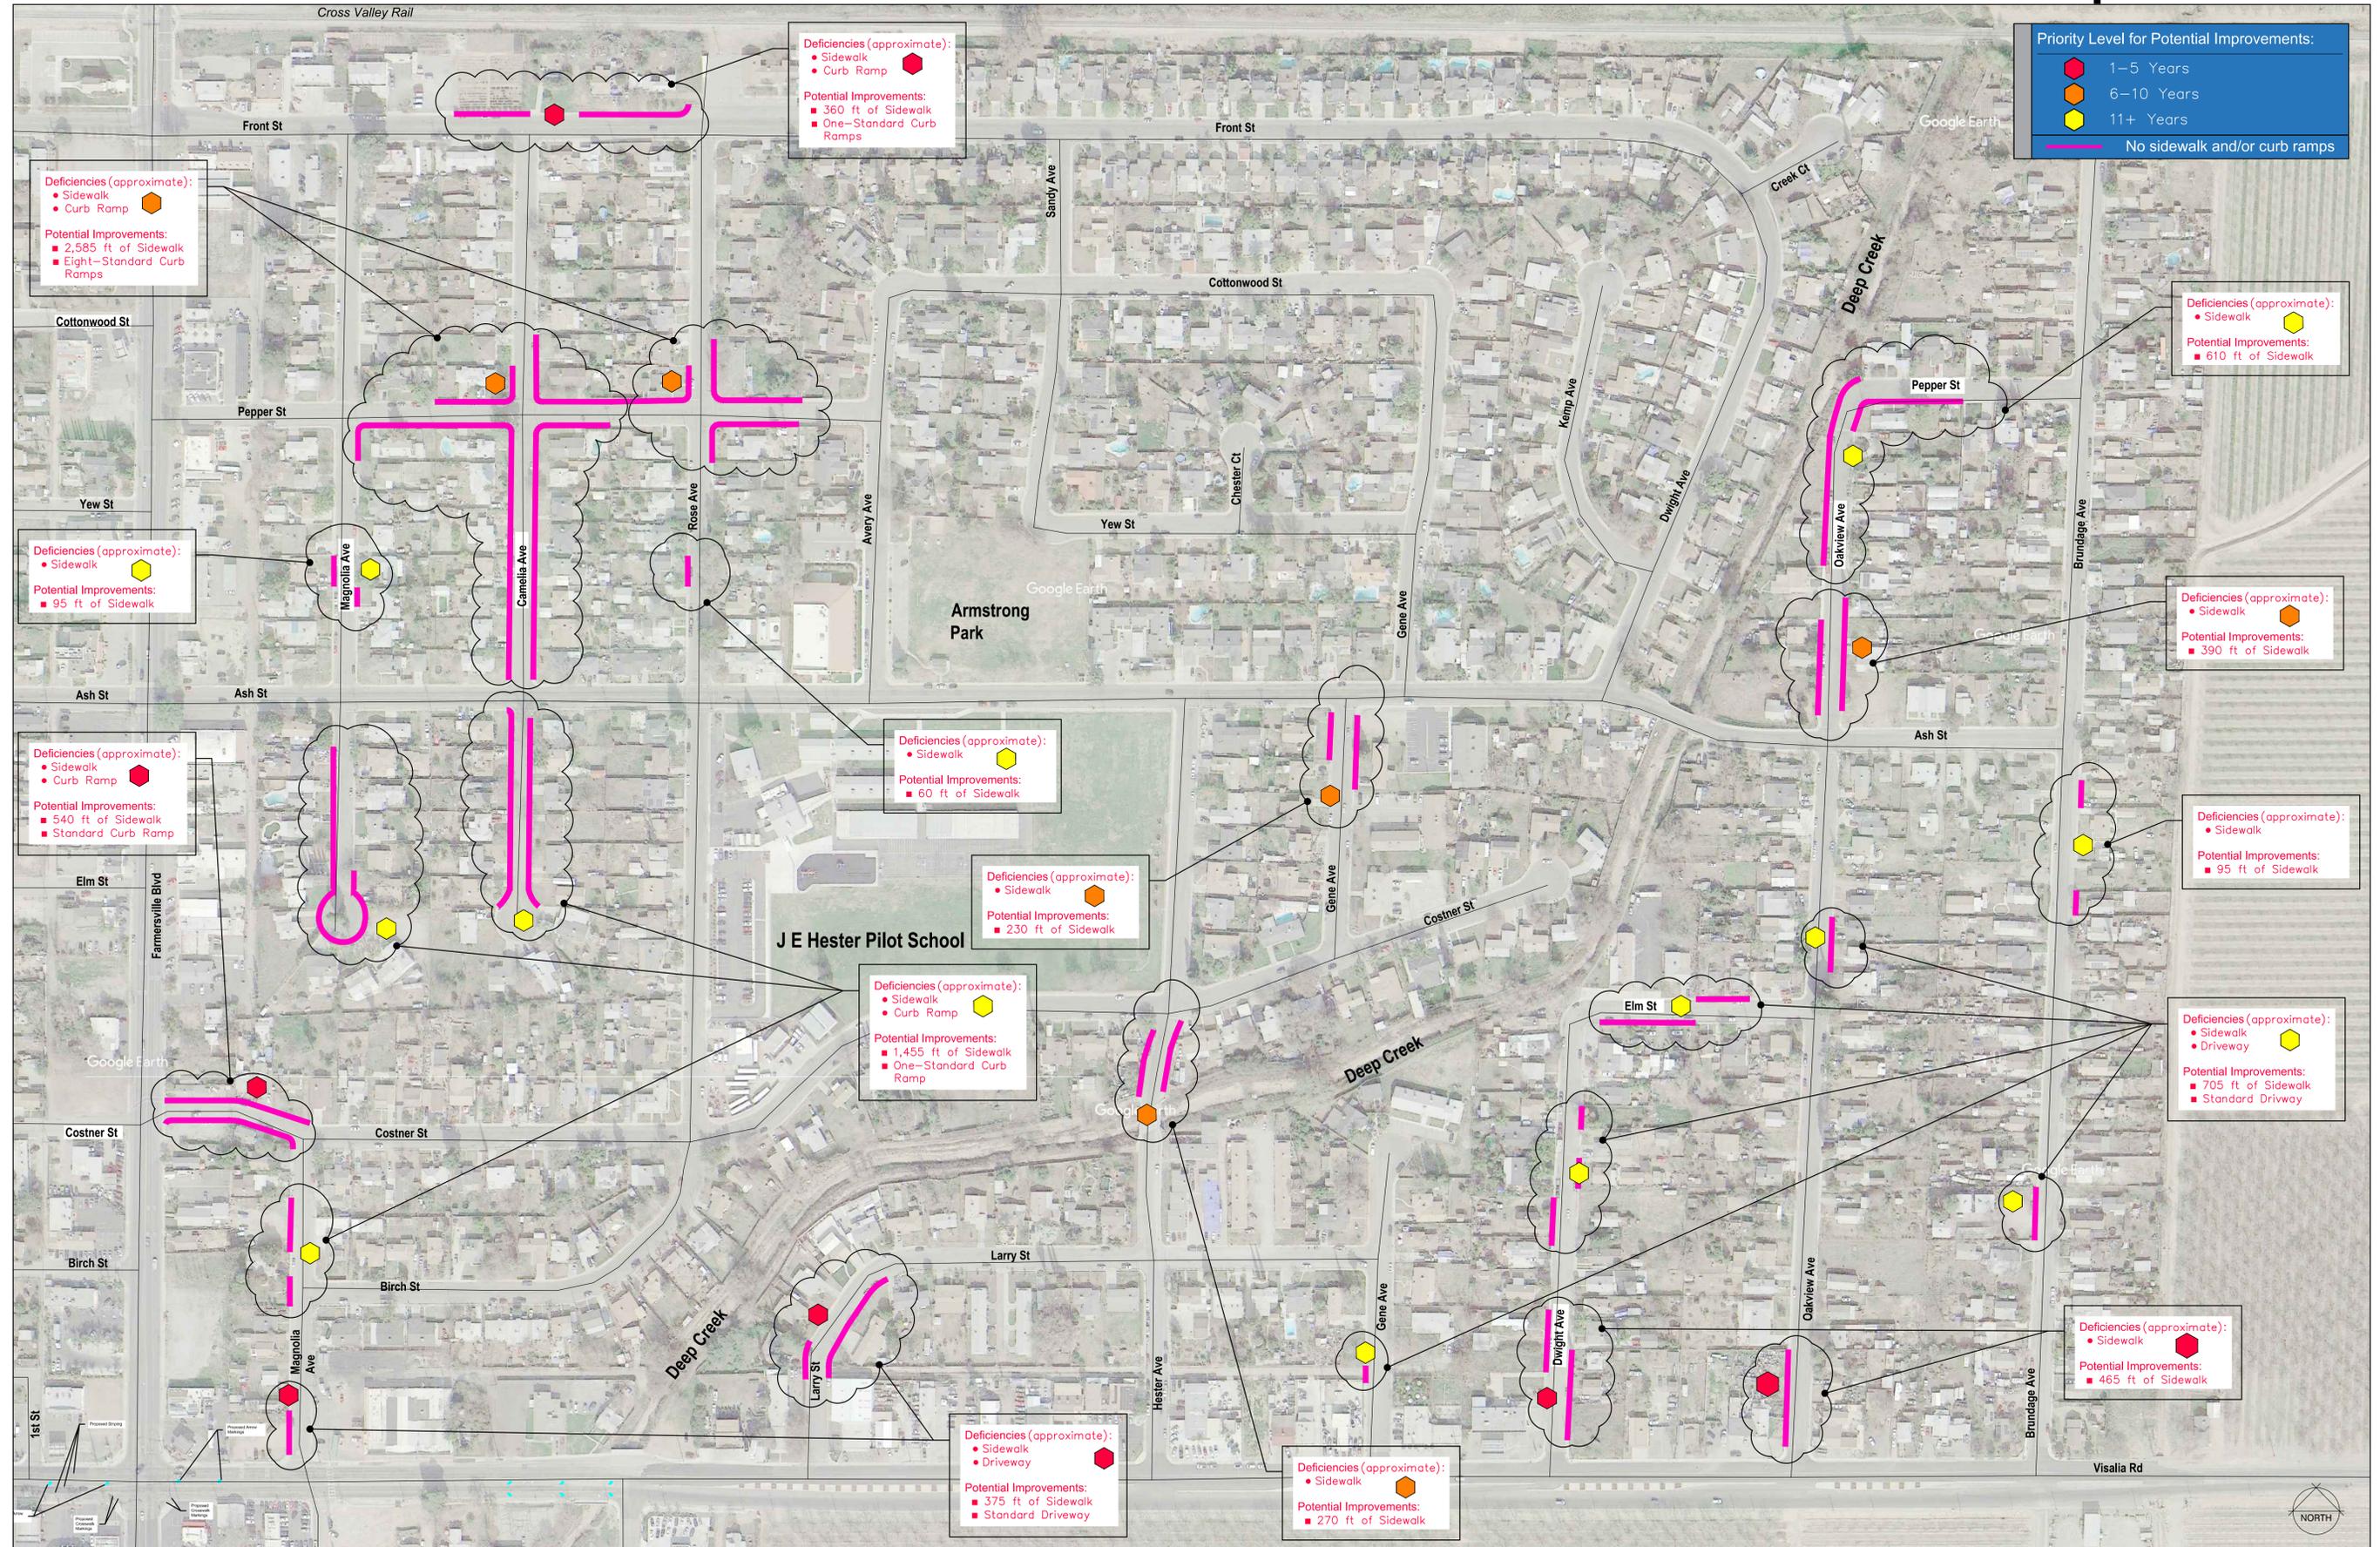
ADA Compliance and Active Transportation Safety Enhancement Plan Figure 6-2E

Sector E

ADA Deficiencies and Potential Improvements
