Farmersville ADA Compliance and Active Transportation Safety Plan

City of Farmersville

Final

November 2019

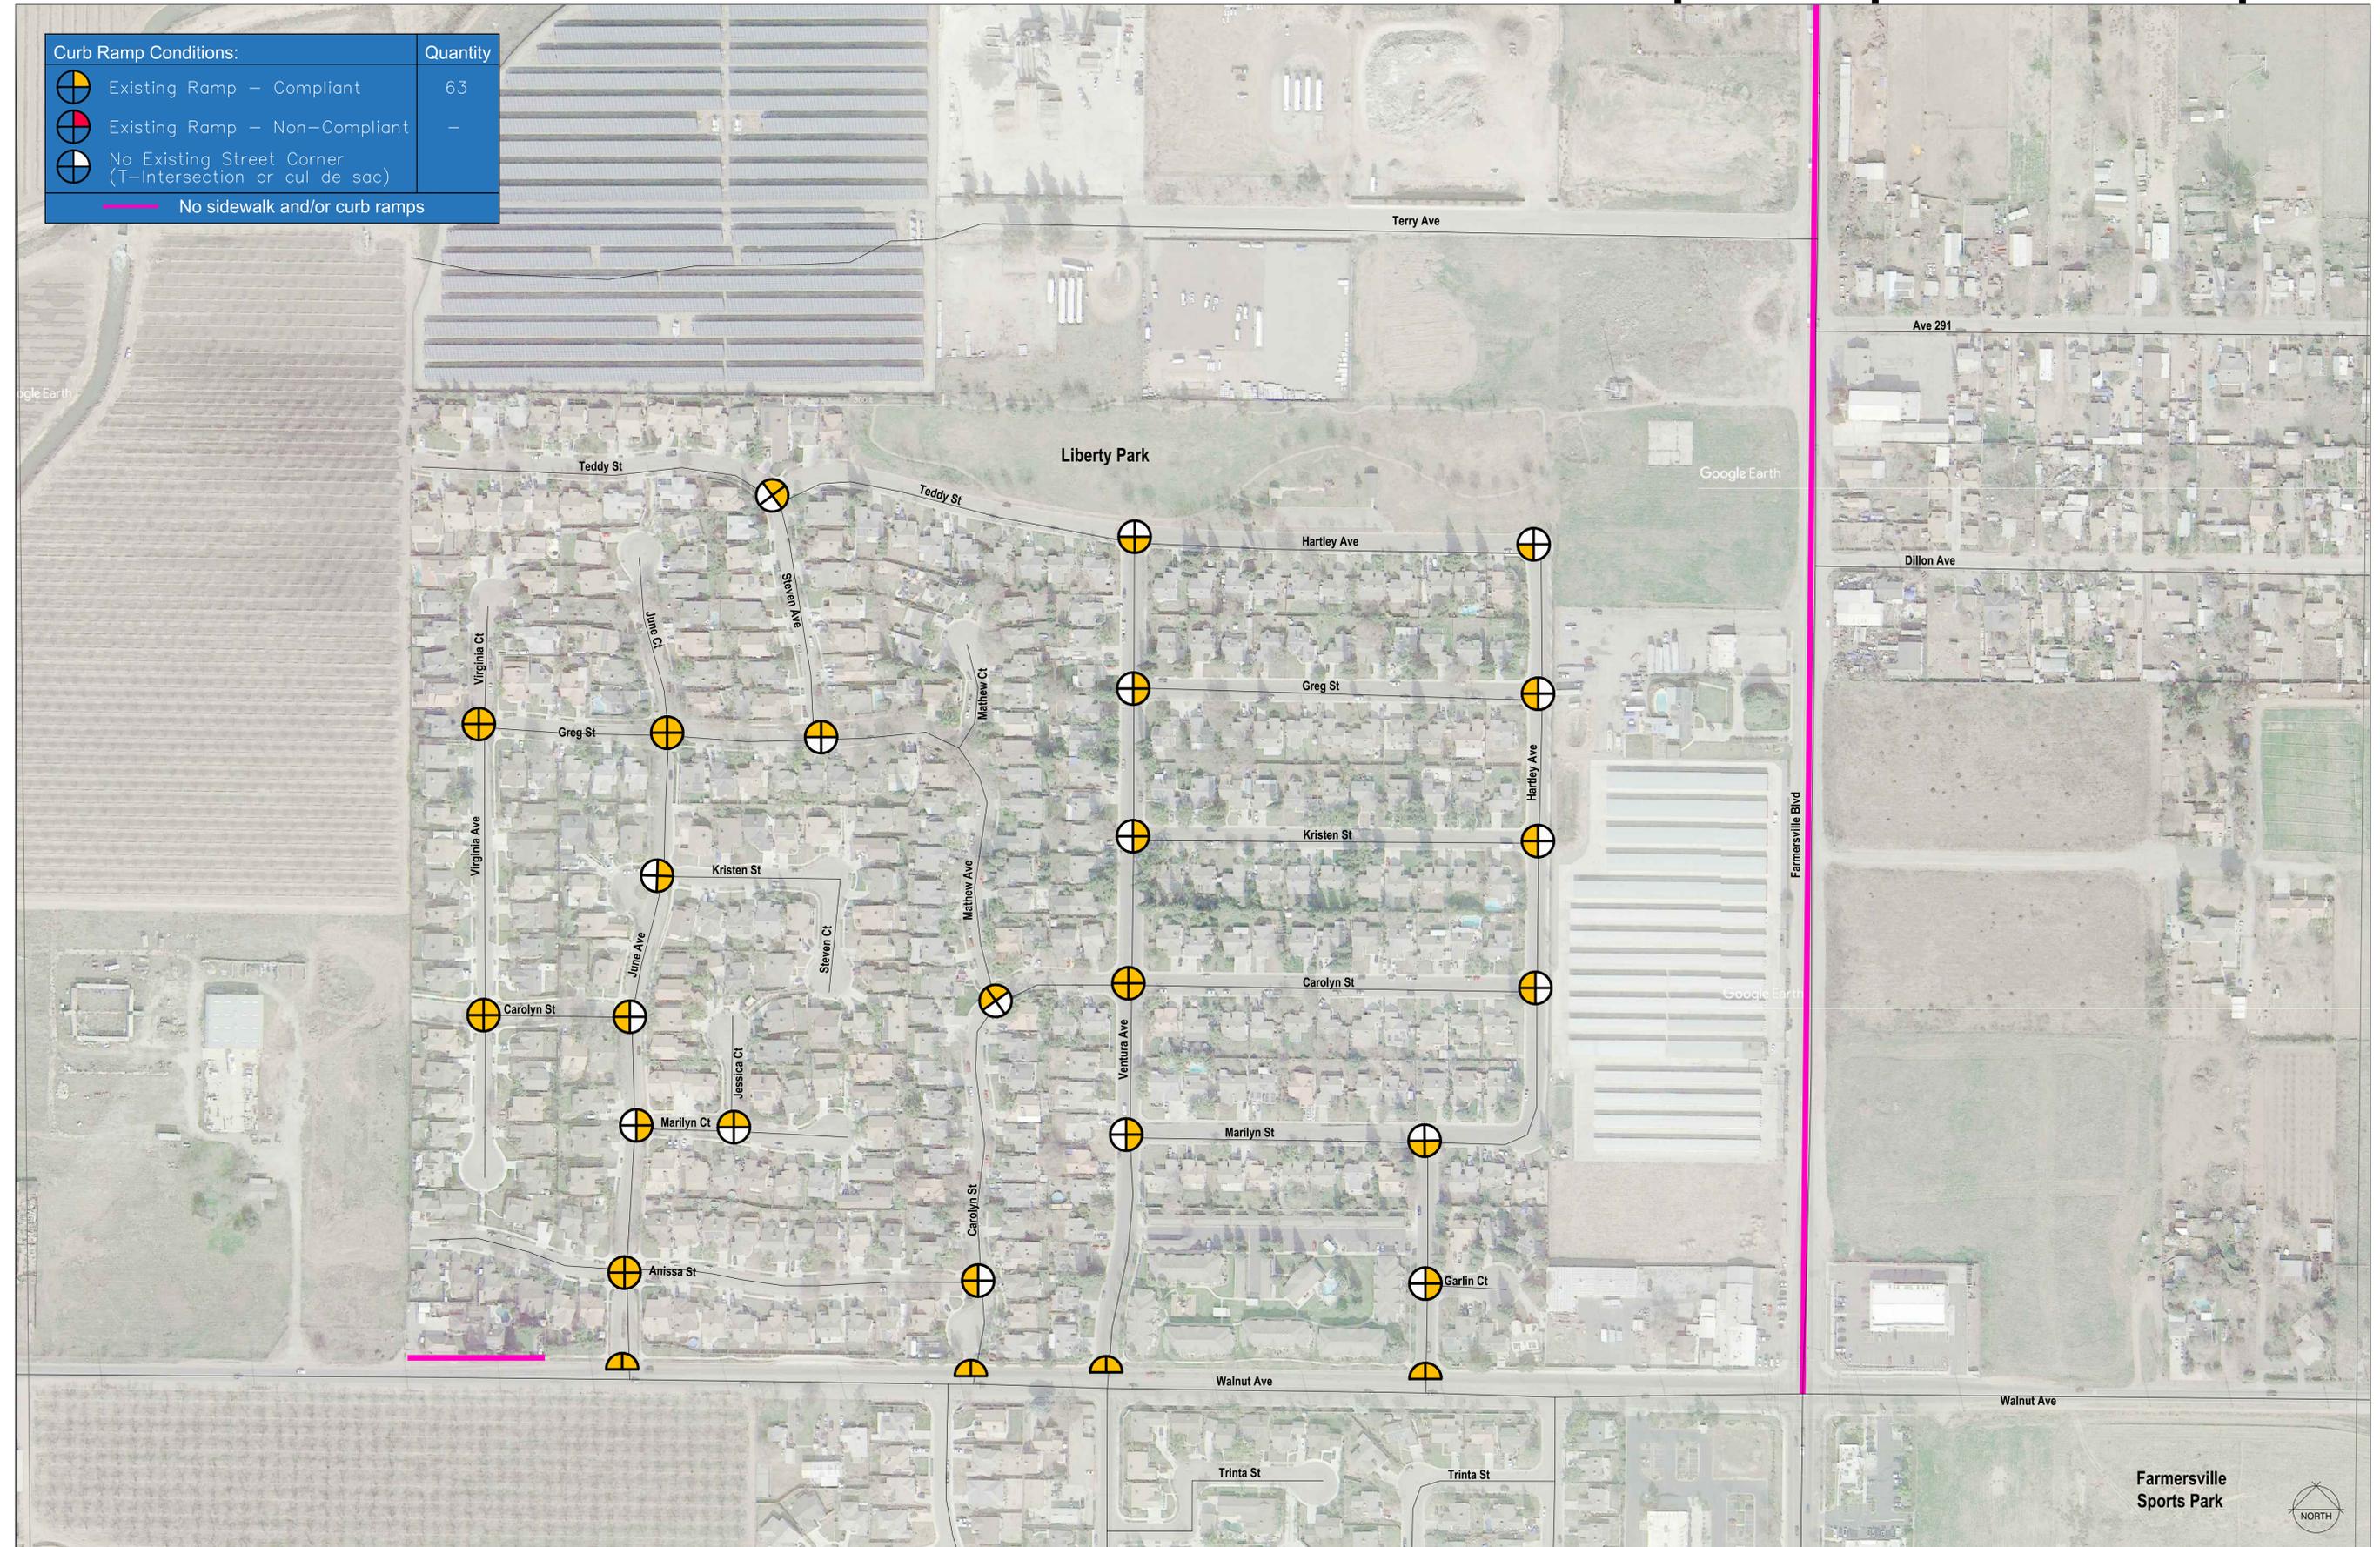
Figure 6-3A

Sector A

Curb Ramps: Compliant/Non-Compliant

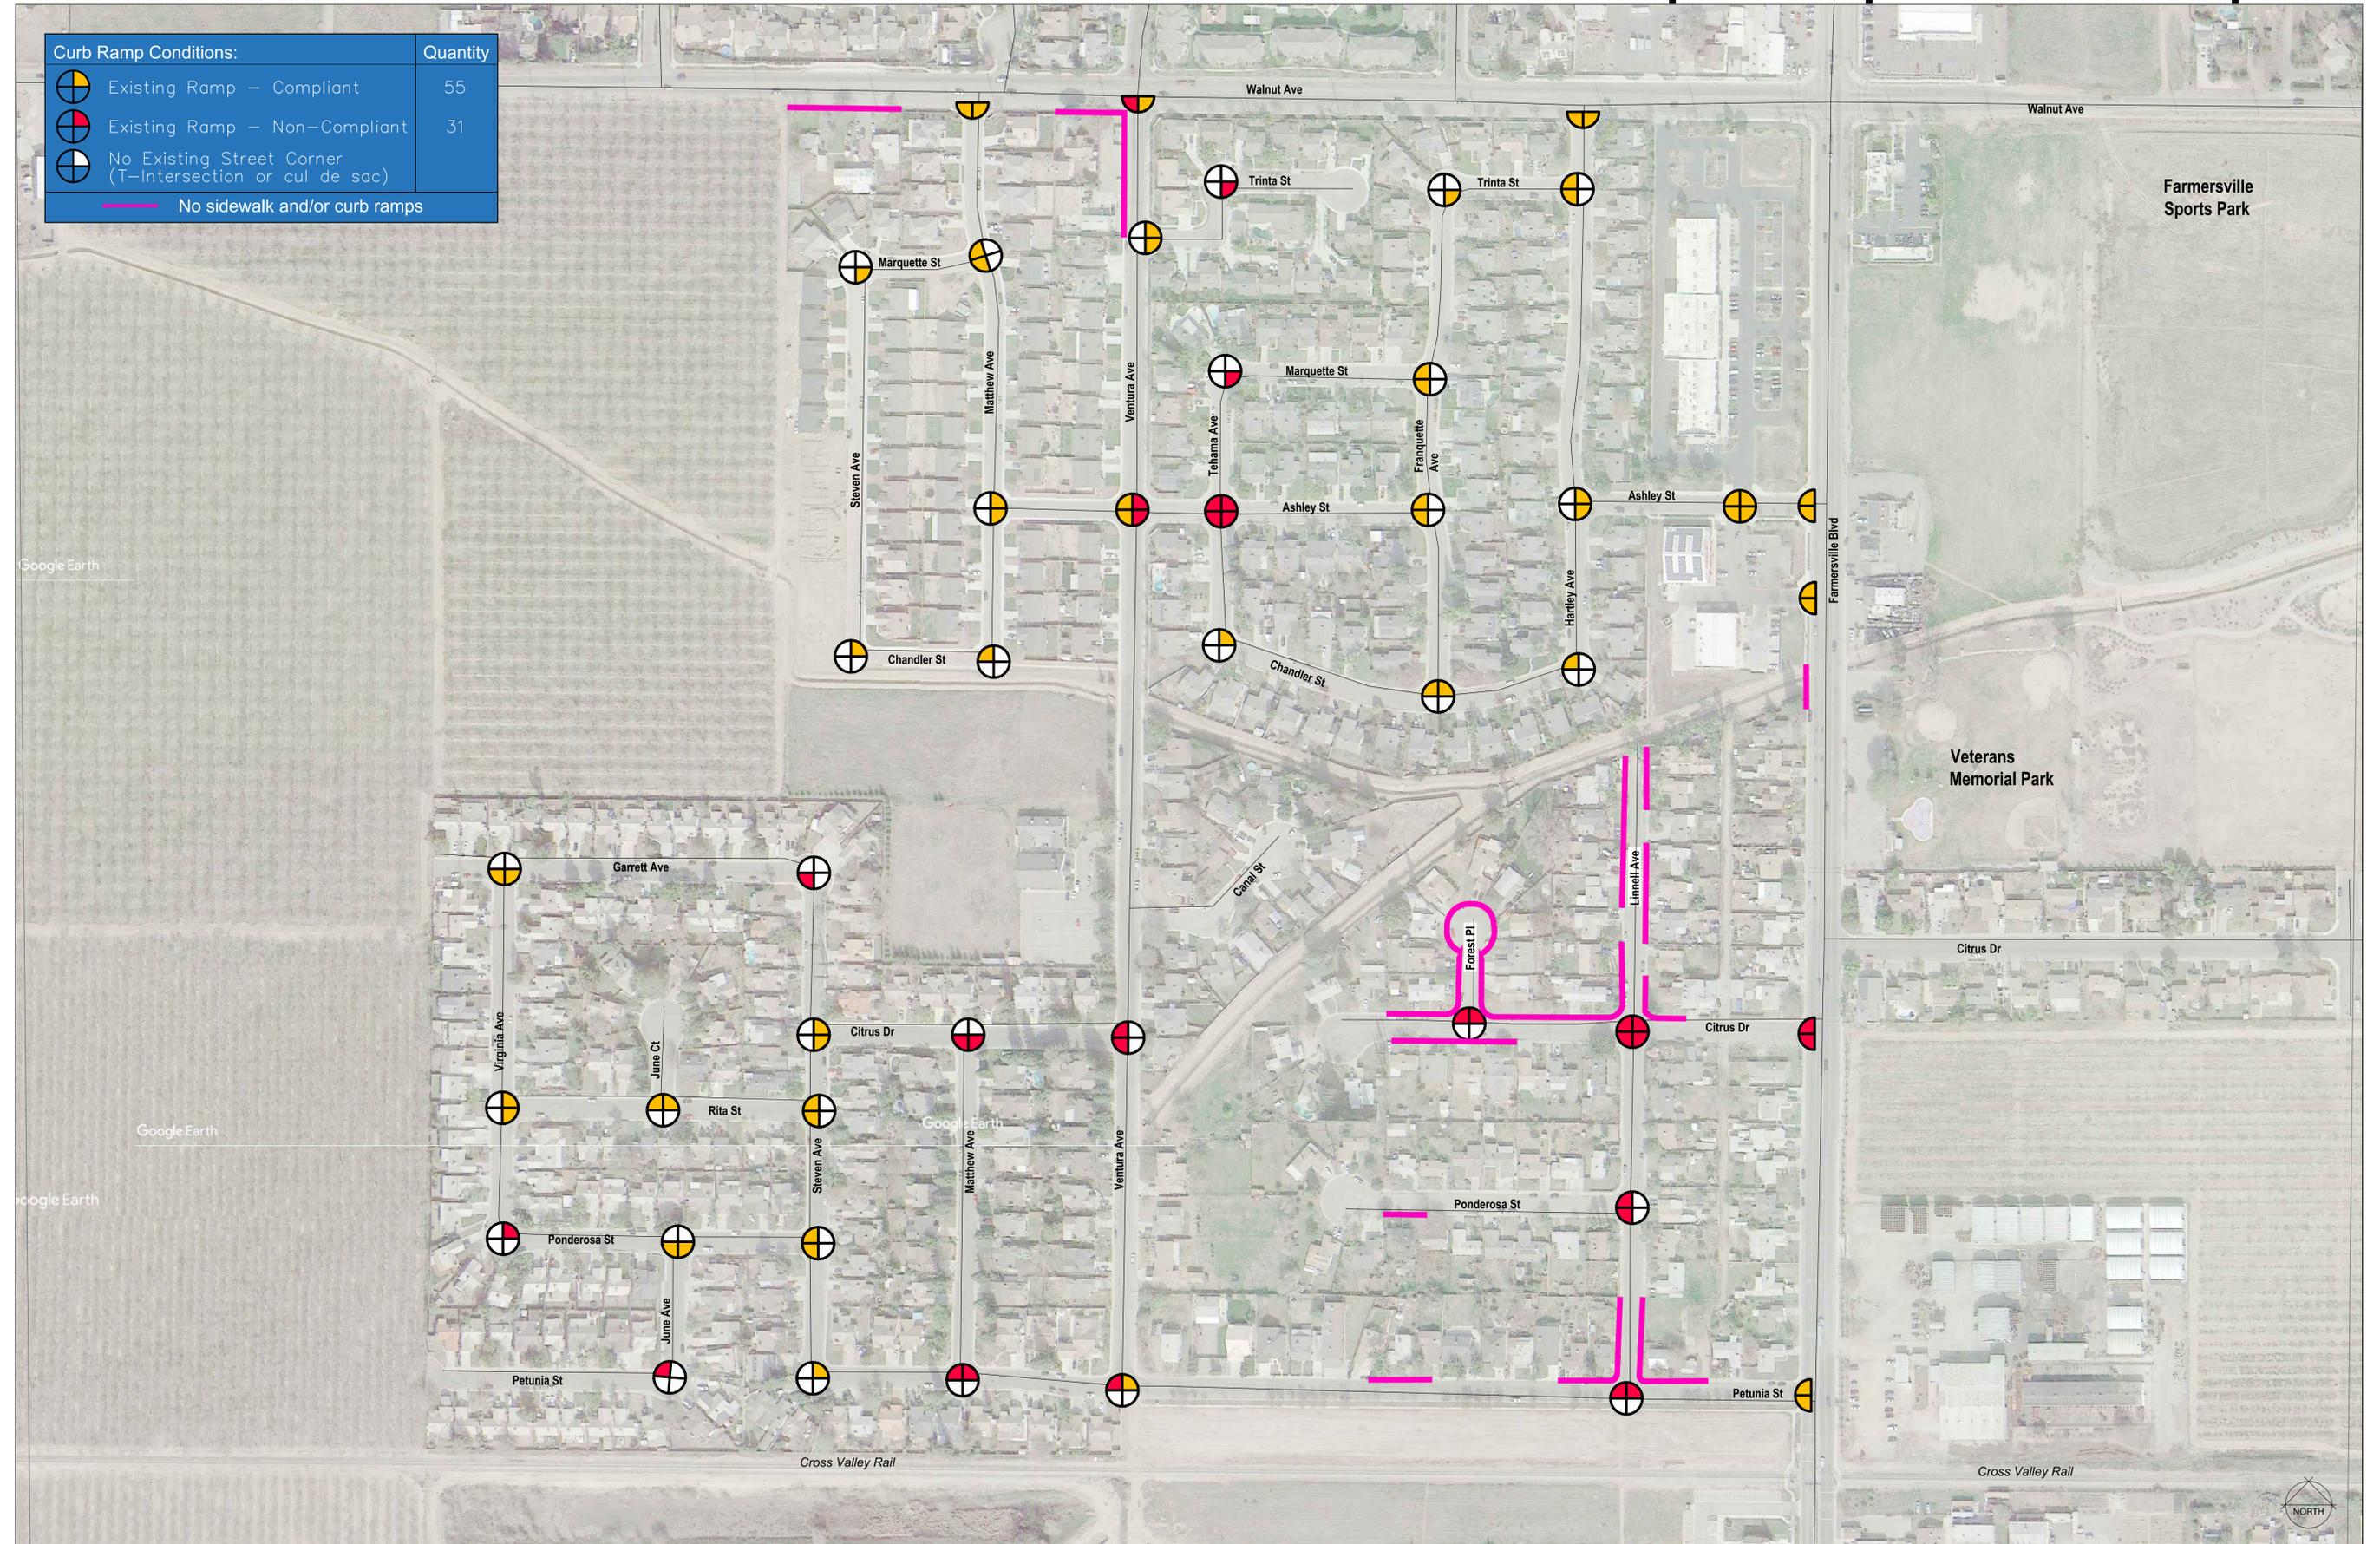
ADA Compliance and Active Transportation Safety Enhancement Plan **Figure 6-3B**

Sector B

Curb Ramps: Compliant/Non-Compliant

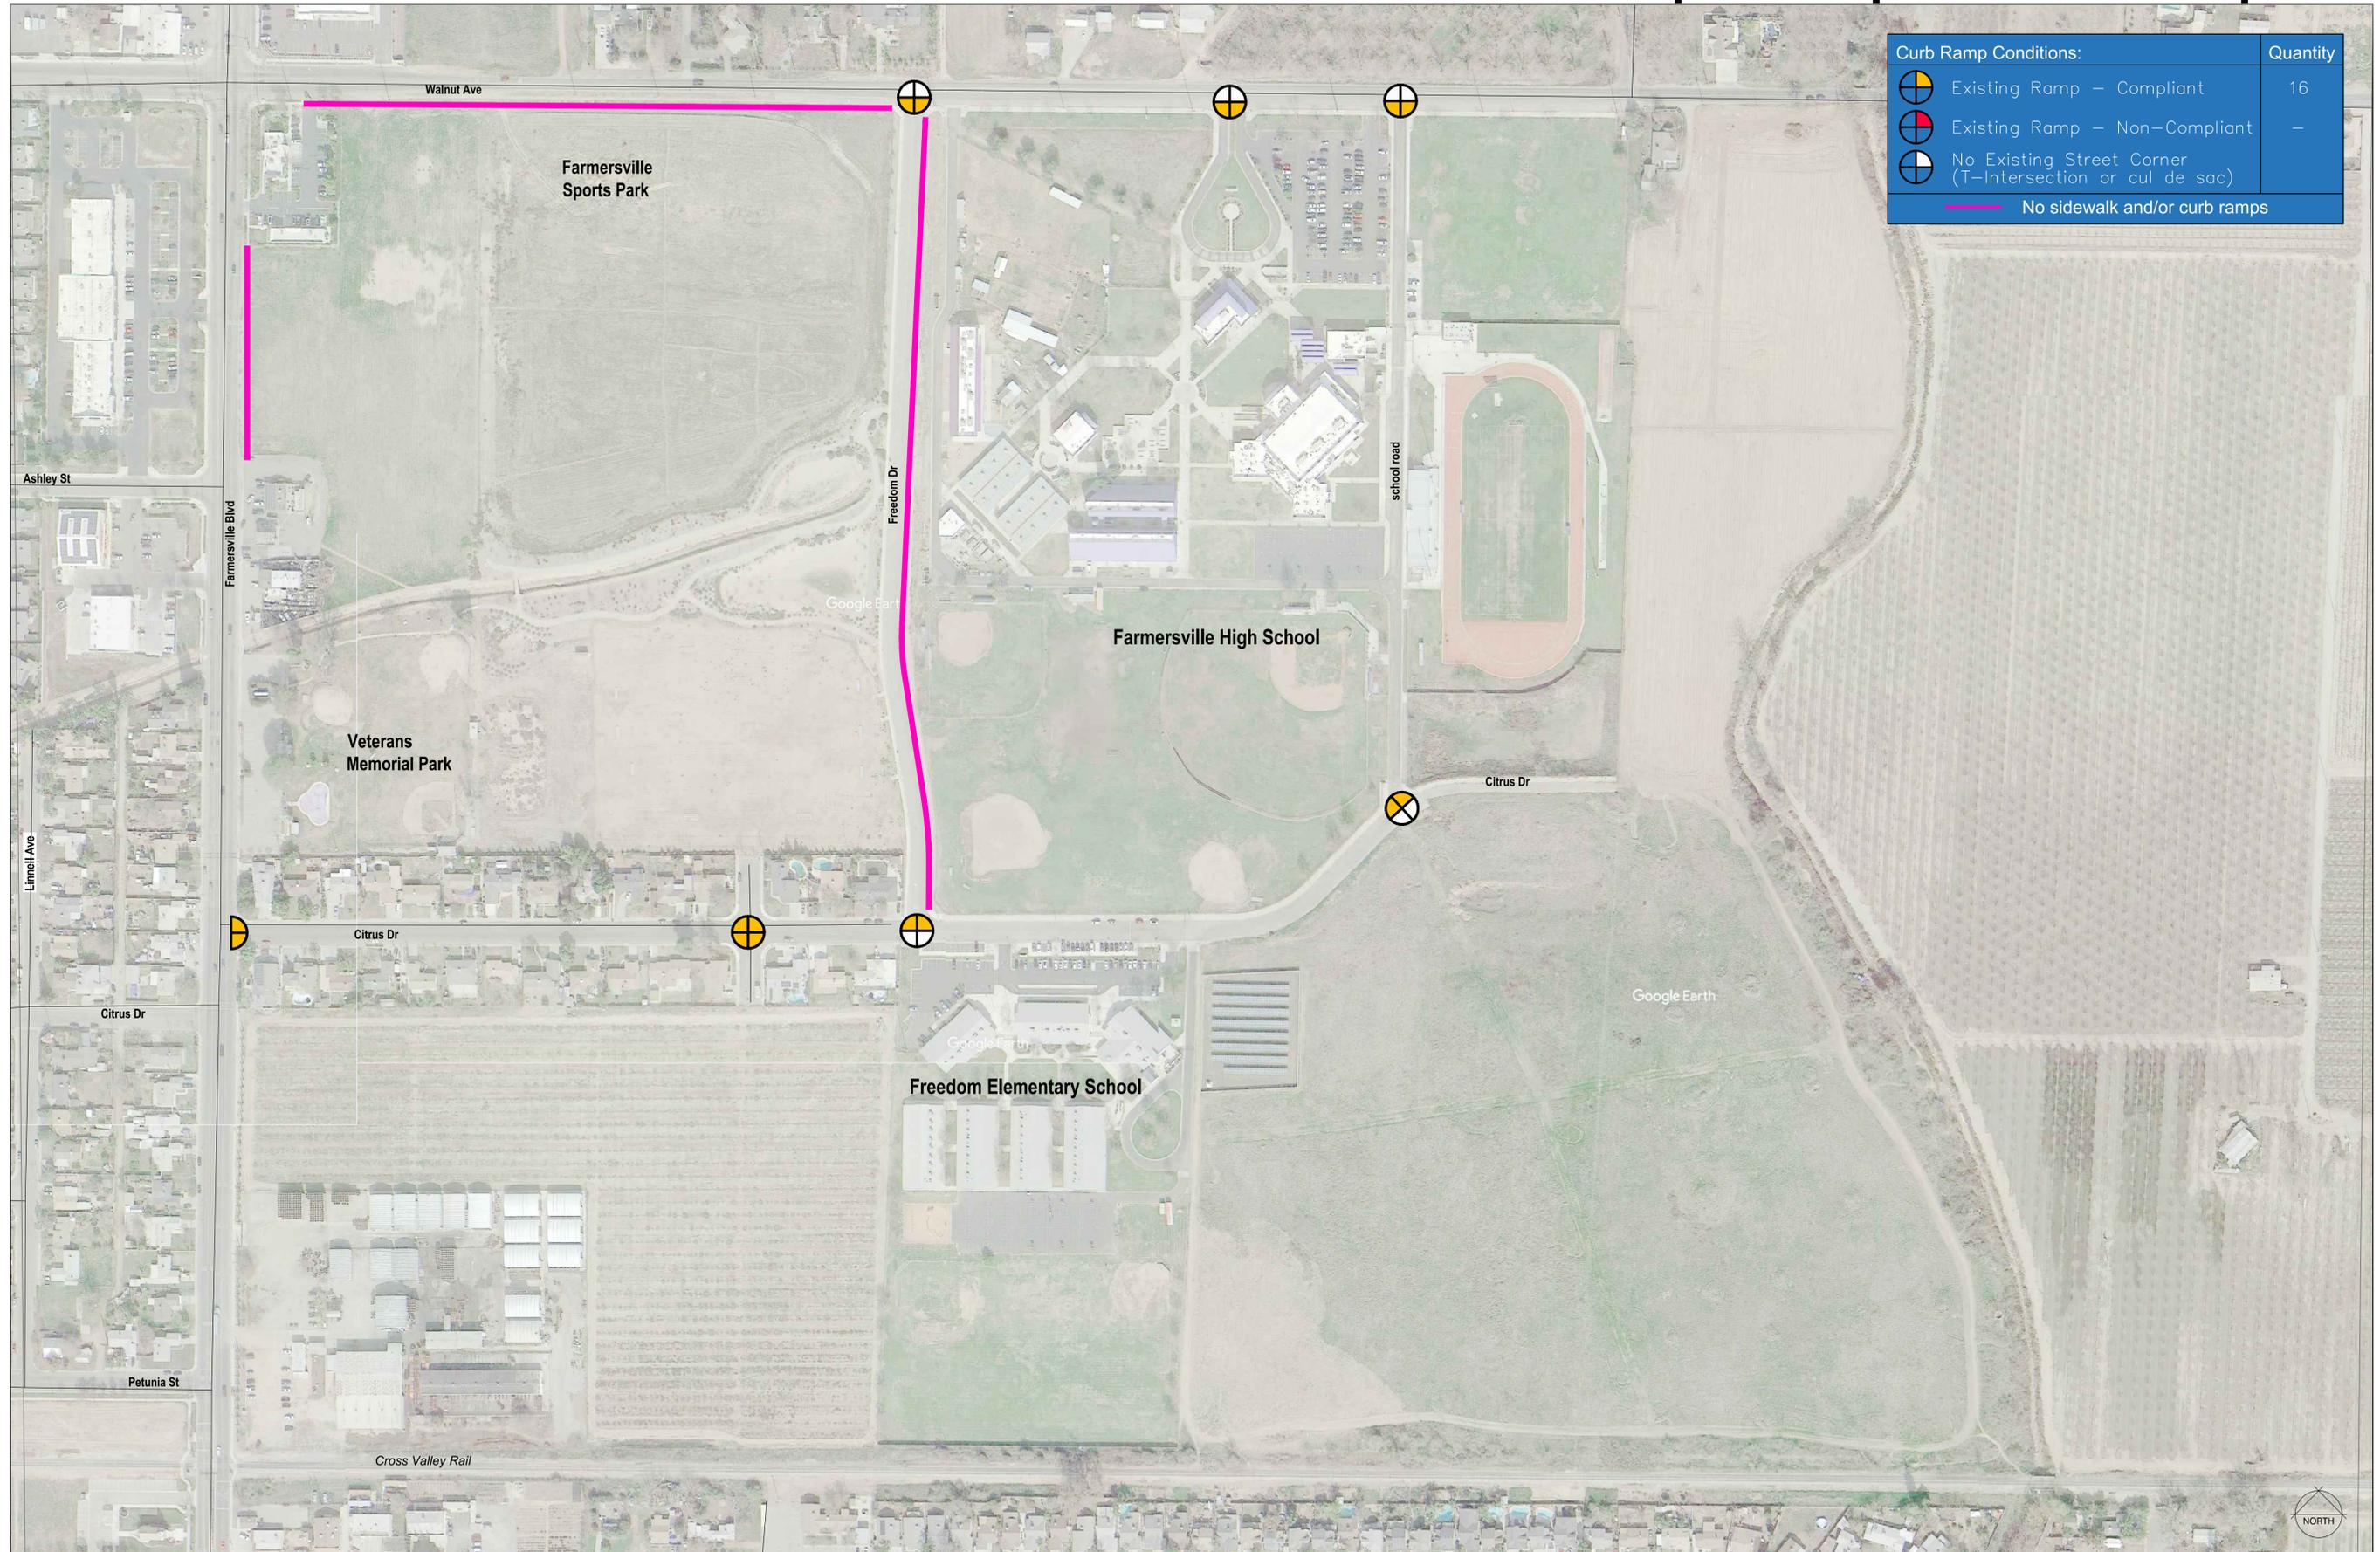
ADA Compliance and Active Transportation Safety Enhancement Plan **Figure 6-3C**

Sector C

Curb Ramps: Compliant/Non-Compliant

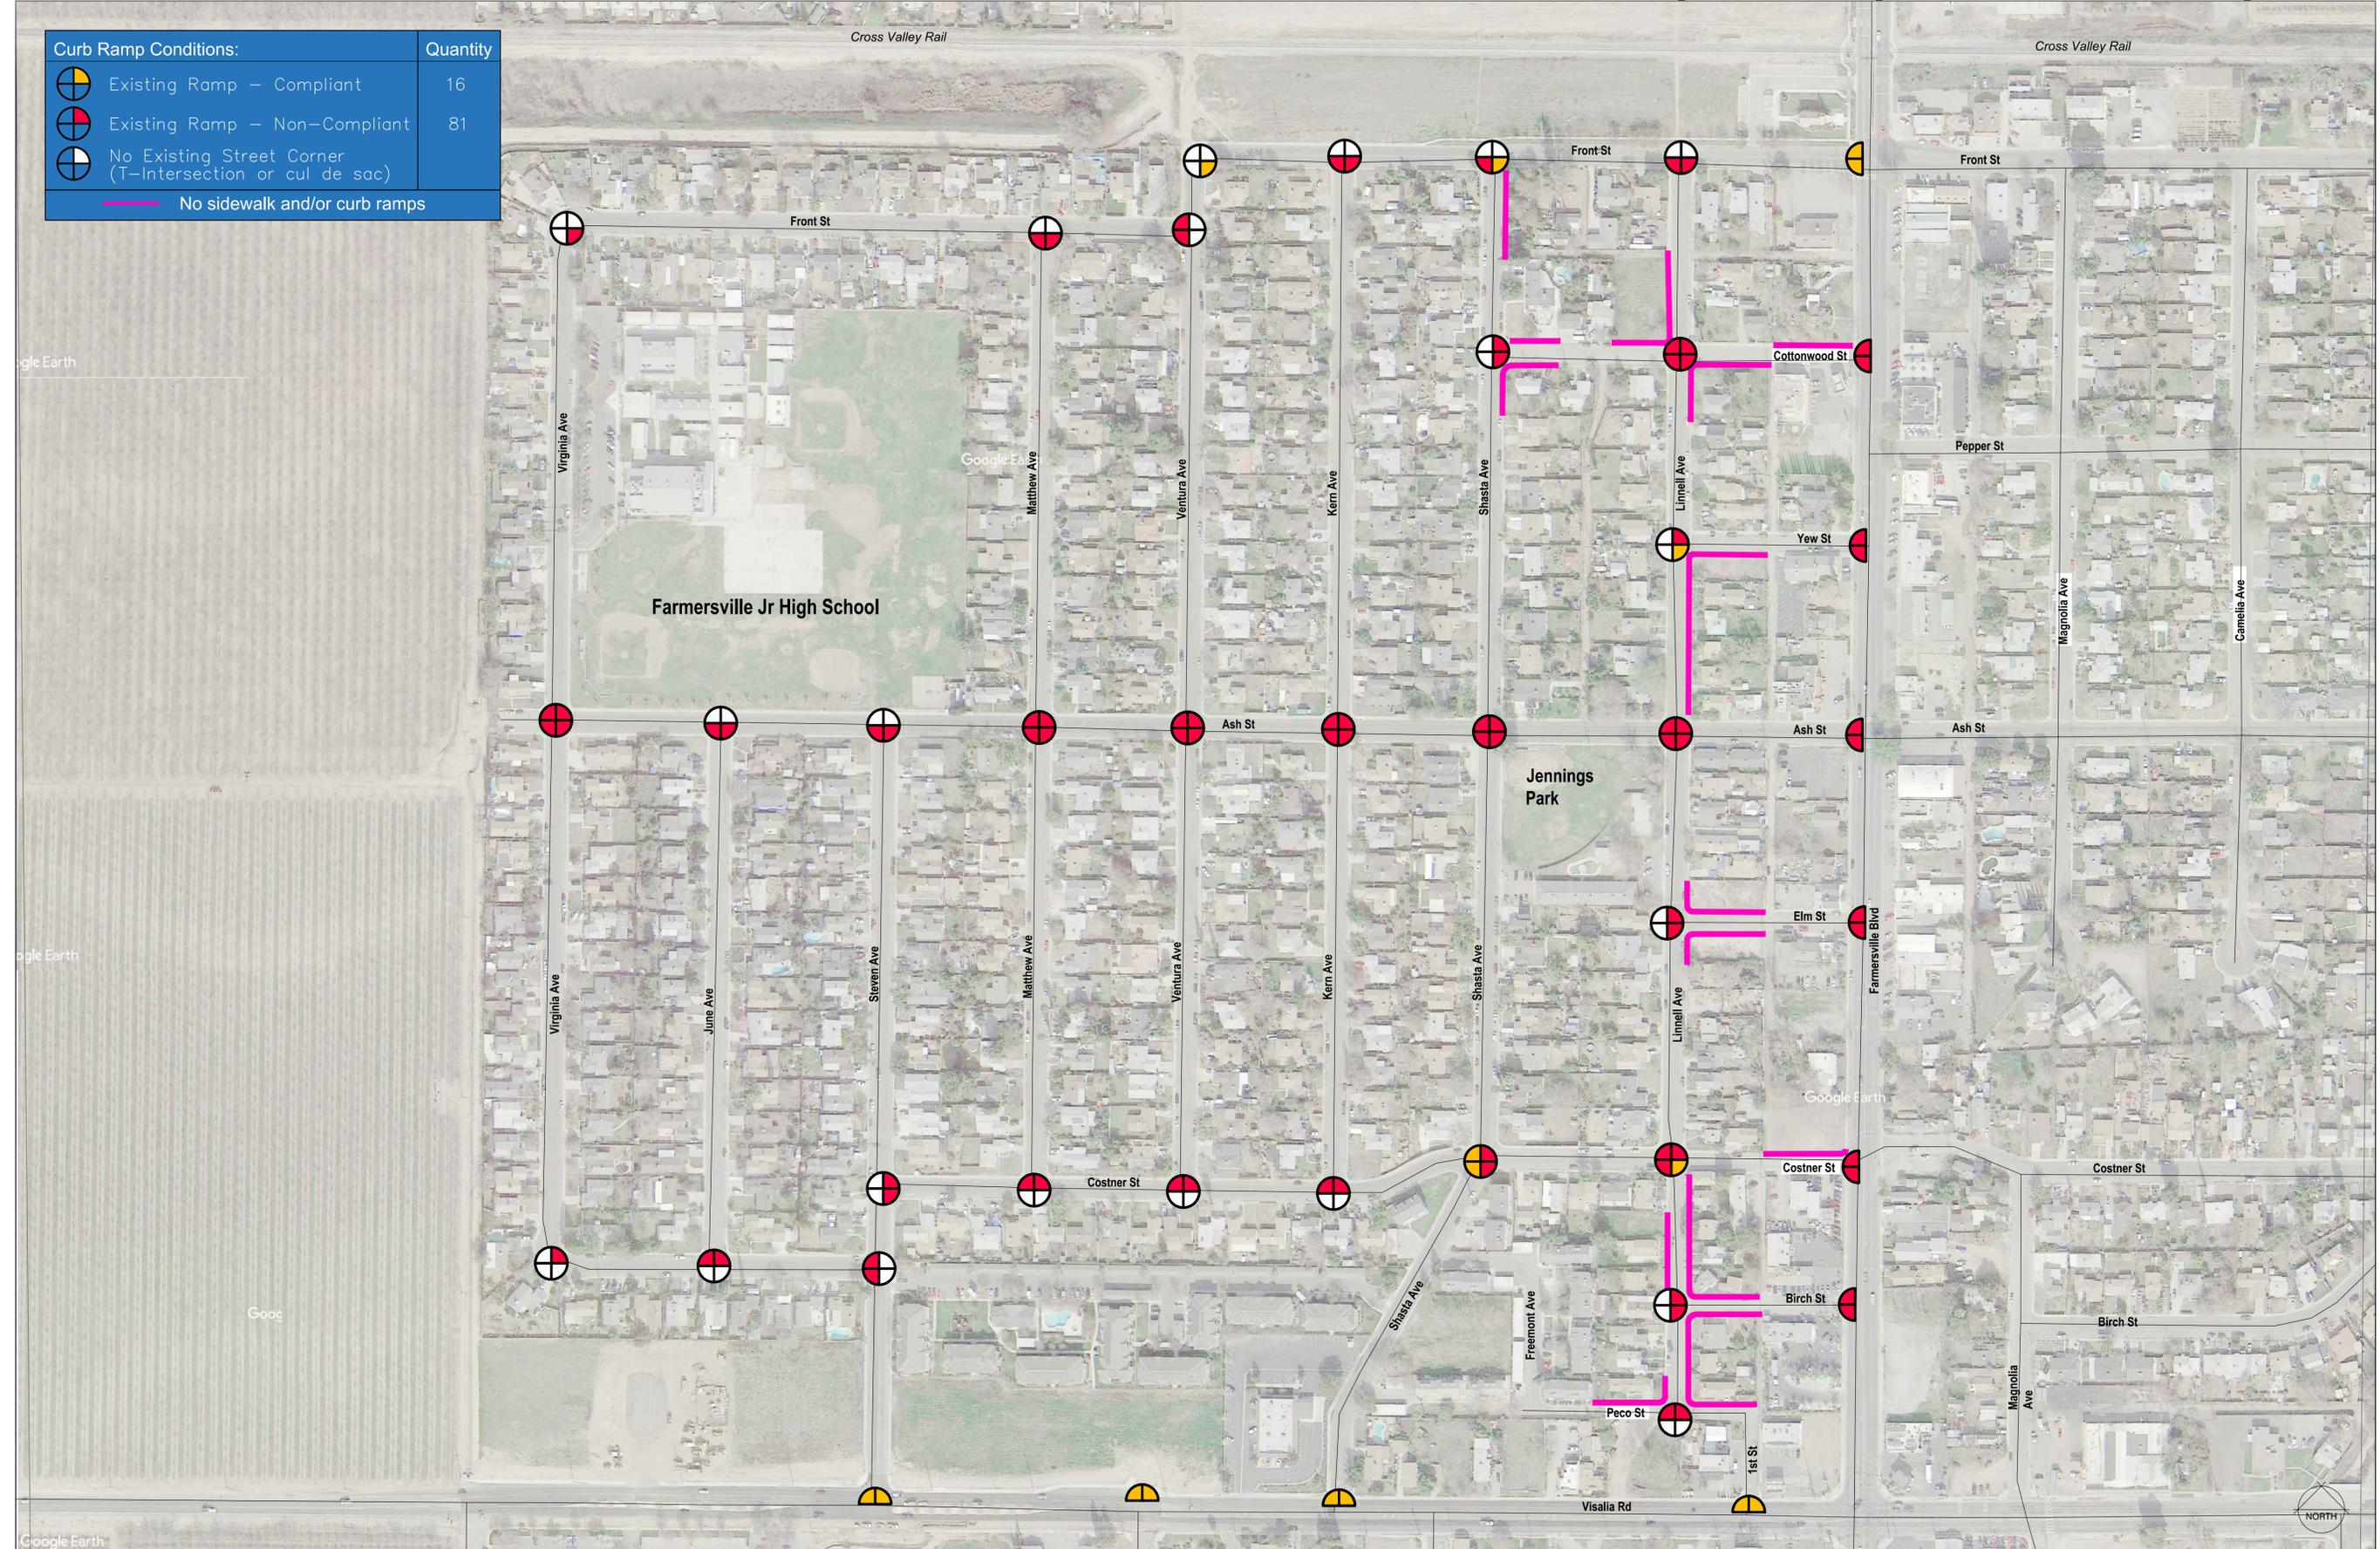
Figure 6-3D

Curb Ramps: Compliant/Non-Compliant

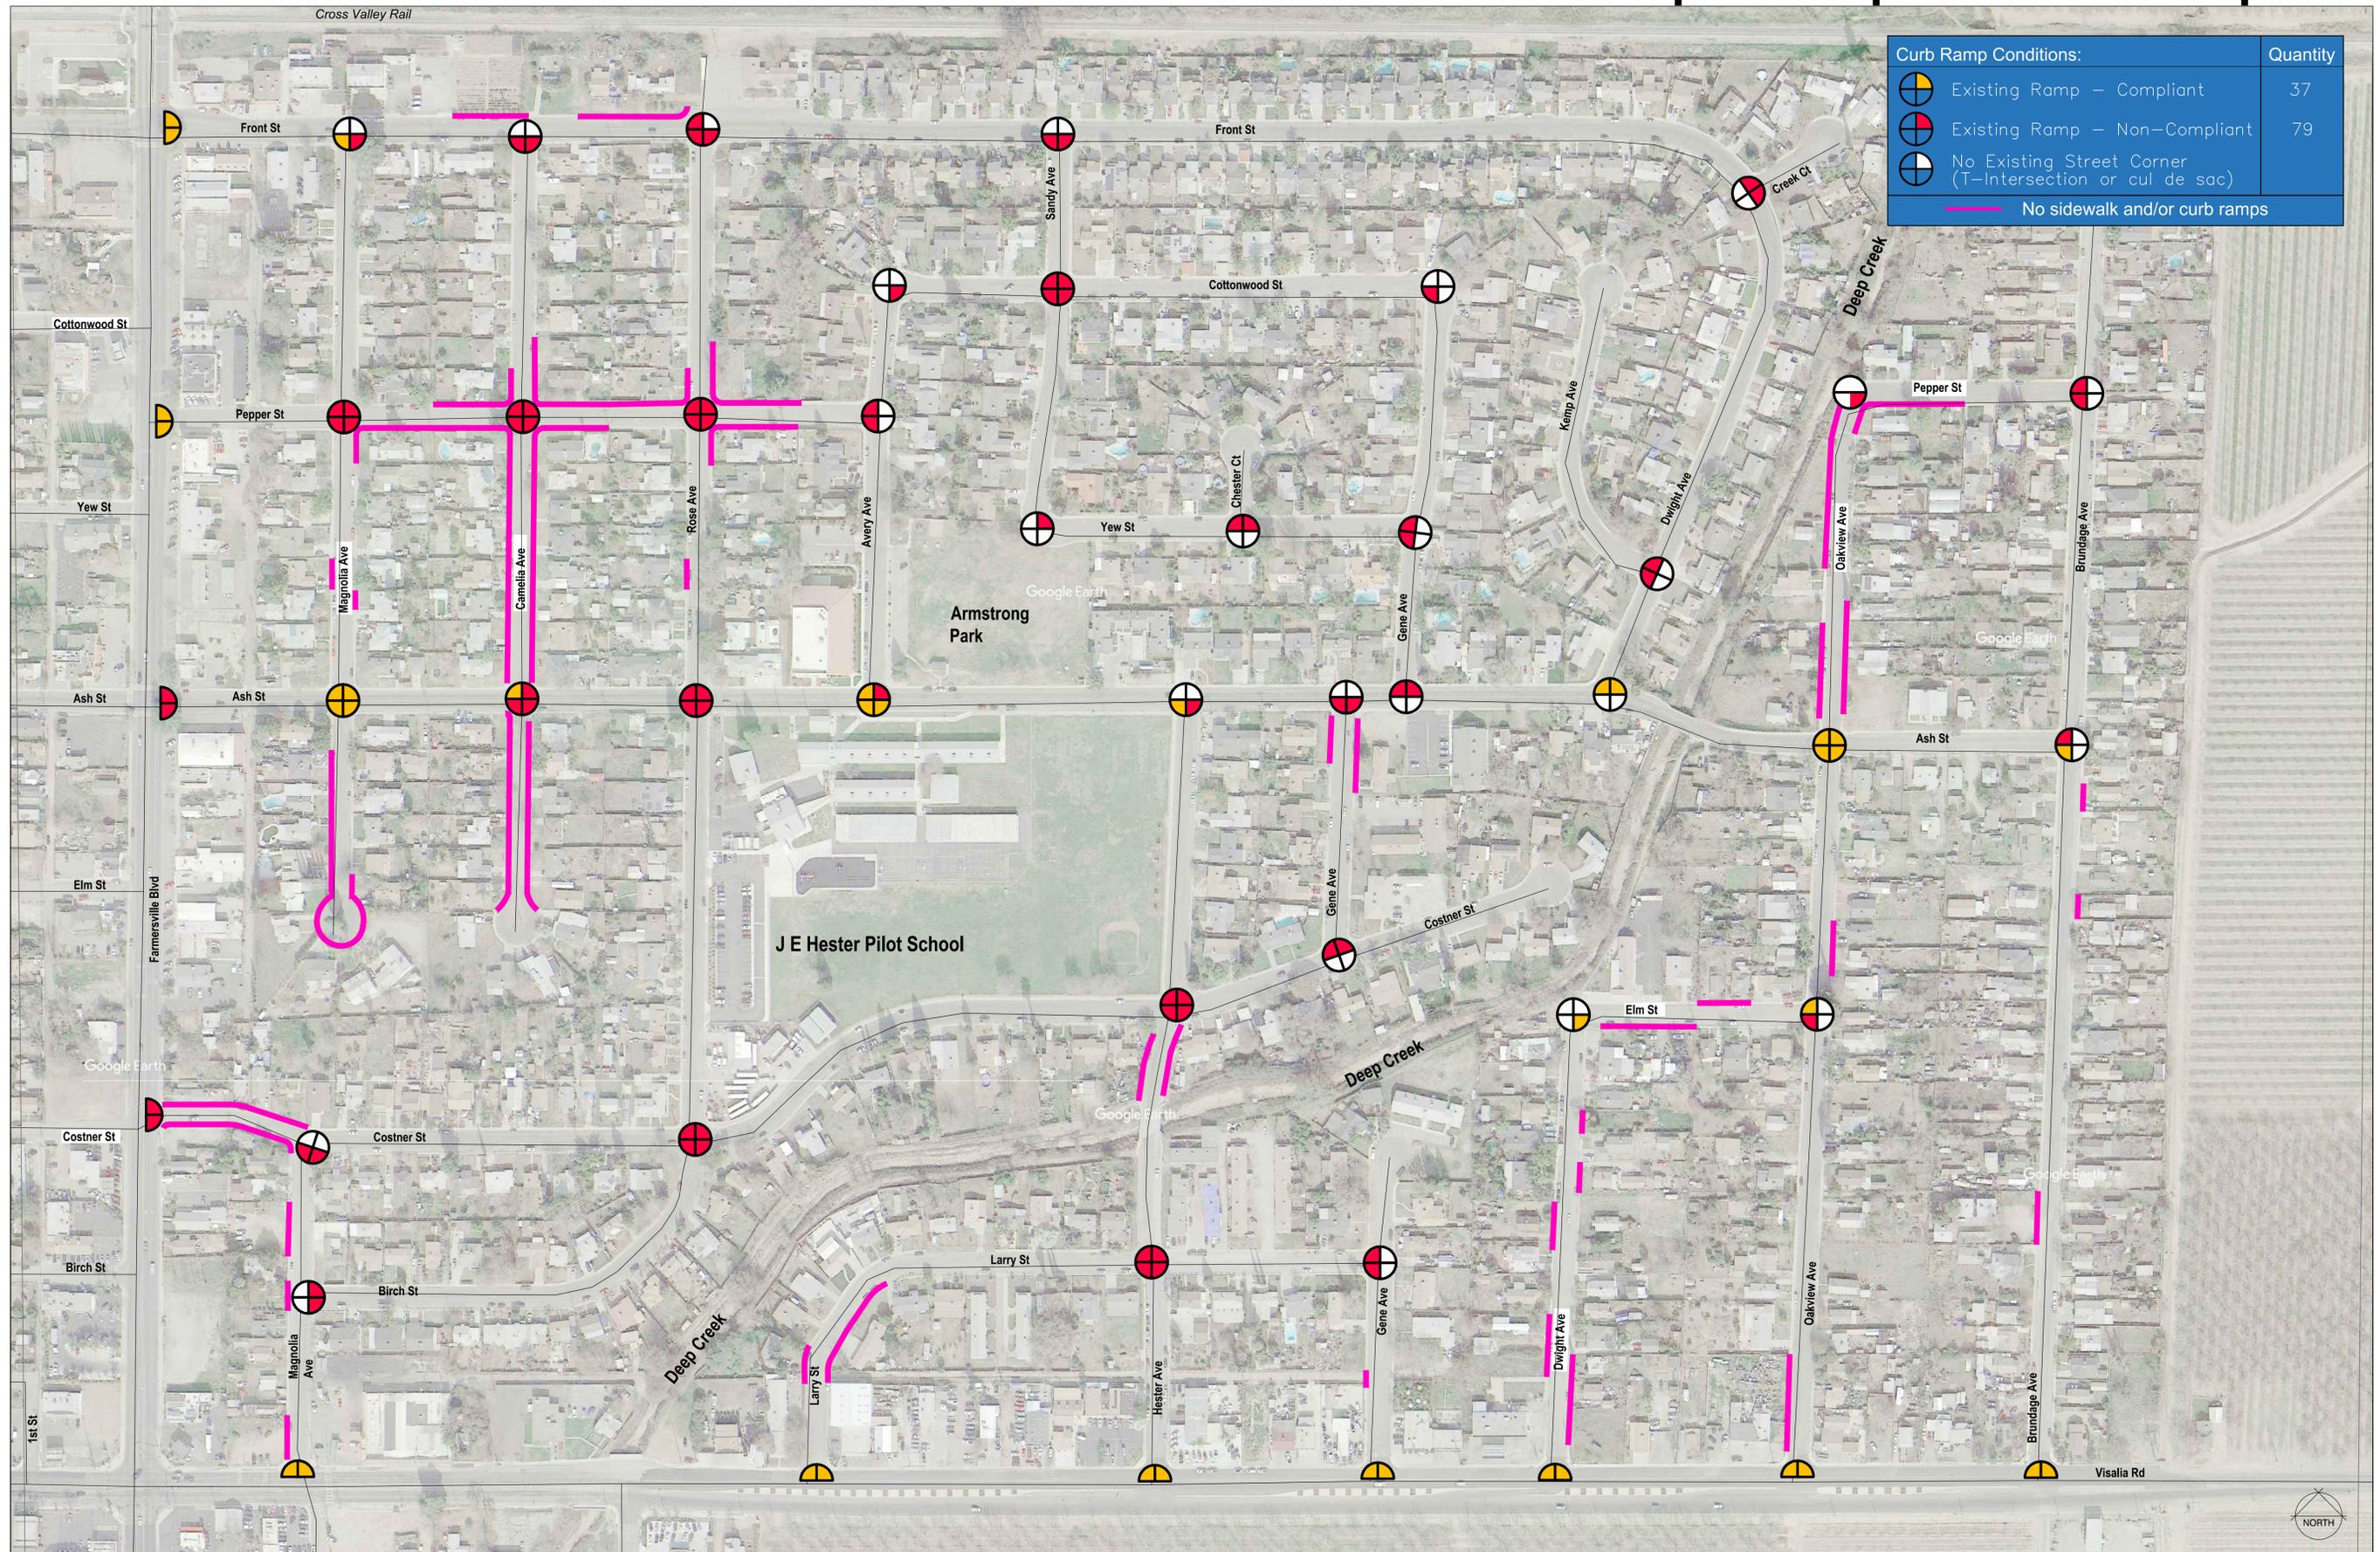
Figure 6-3E

Curb Ramps: Compliant/Non-Compliant

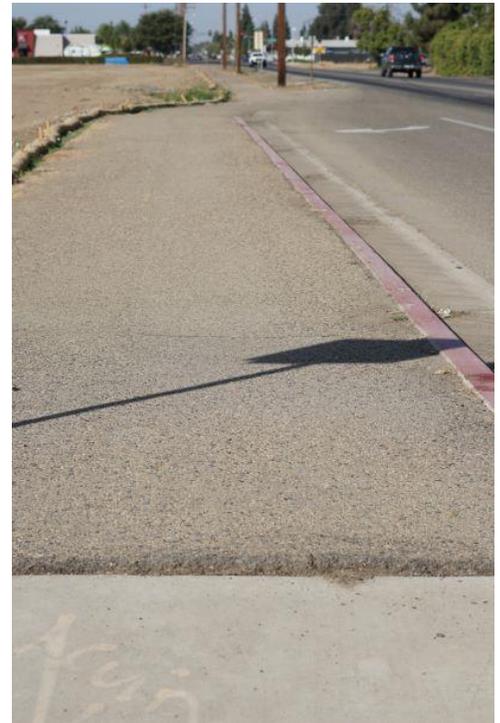
Figure 20 - Missing sidewalk along both sides of E. Walnut St. / N. Freedom Dr.

- Adding sidewalks along Walnut Ave all the way through school (both ends) as well as [N. Freedom Dr. down to E.Citrus Dr.]
- Adding ramp along edge of High School near Citrus

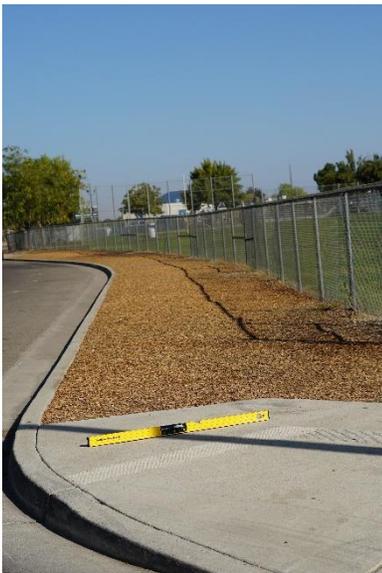
Figure 21 - Side walk was missing on one side of N. Freedom St (High School St.).

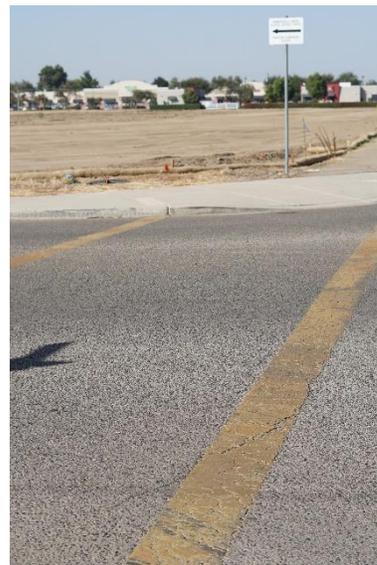
Figure 22 - Cross walks were more common around this sector because there were two schools nearby.

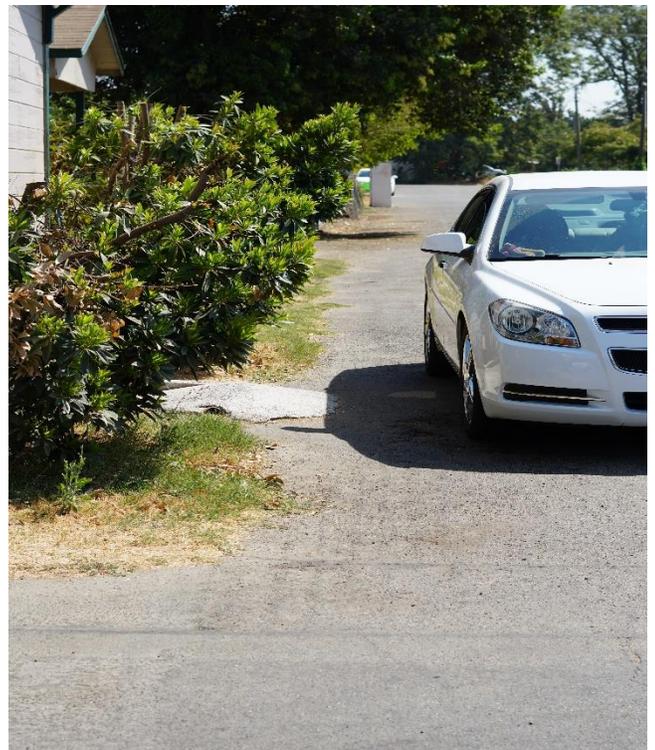
Figure 24 – No sidewalk on this side of the street

- Broken sidewalks
- Very few light fixtures in some areas
- Incomplete sidewalks/ramps
- Designating centralized mailboxes and removing the mailboxes obstructing sidewalks
- Housing code enforcement centered around blighted areas

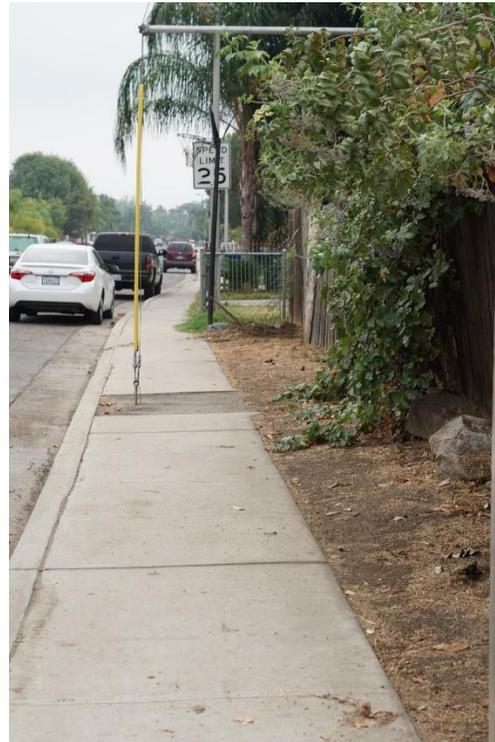
Figure 29 – Walkability hampered by utility interruption

- Broken sidewalks
- Very few light fixtures south of Ash
- Incomplete sidewalks/ramps
- Housing code enforcement centered around blighted areas

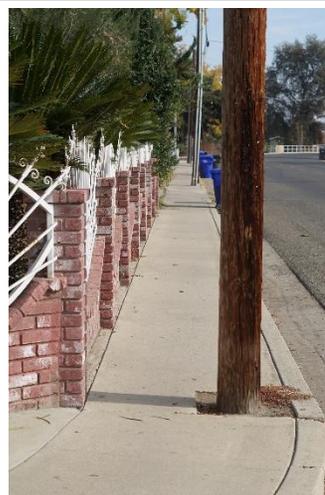
Figure 32 –
utility
interrupting
sidewalk

Examples of sidewalk conditions that impact the overall walkability of this neighborhood.

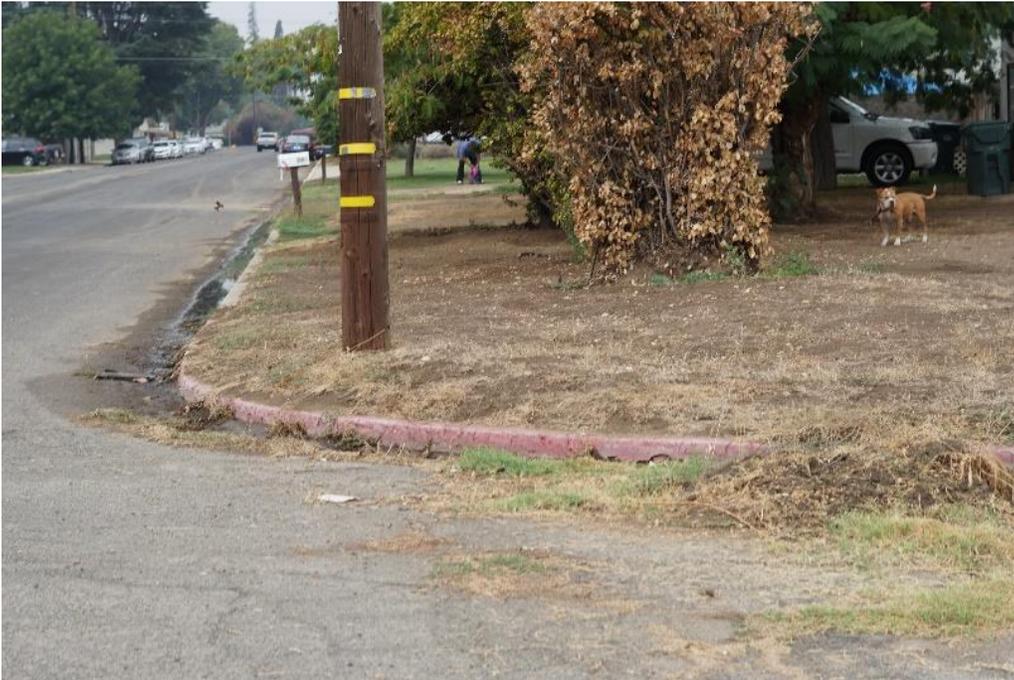
Figure 33 - Here we have a picture of a segment in sector E that shows the lack of sidewalk which was a common occurrence.

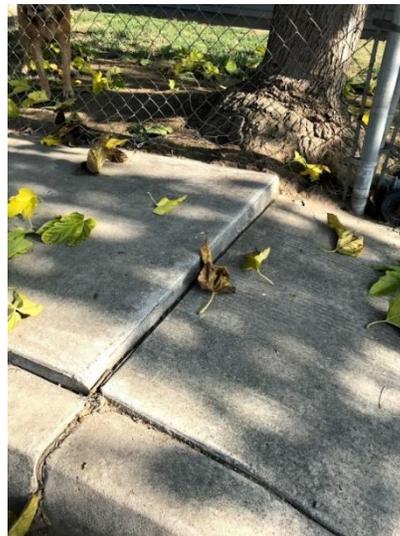
Figure 39 - trip hazard/obstacle for a person to walk past safely.
