Farmersville ADA Compliance and Active Transportation Safety Plan

City of Farmersville

Final

November 2019

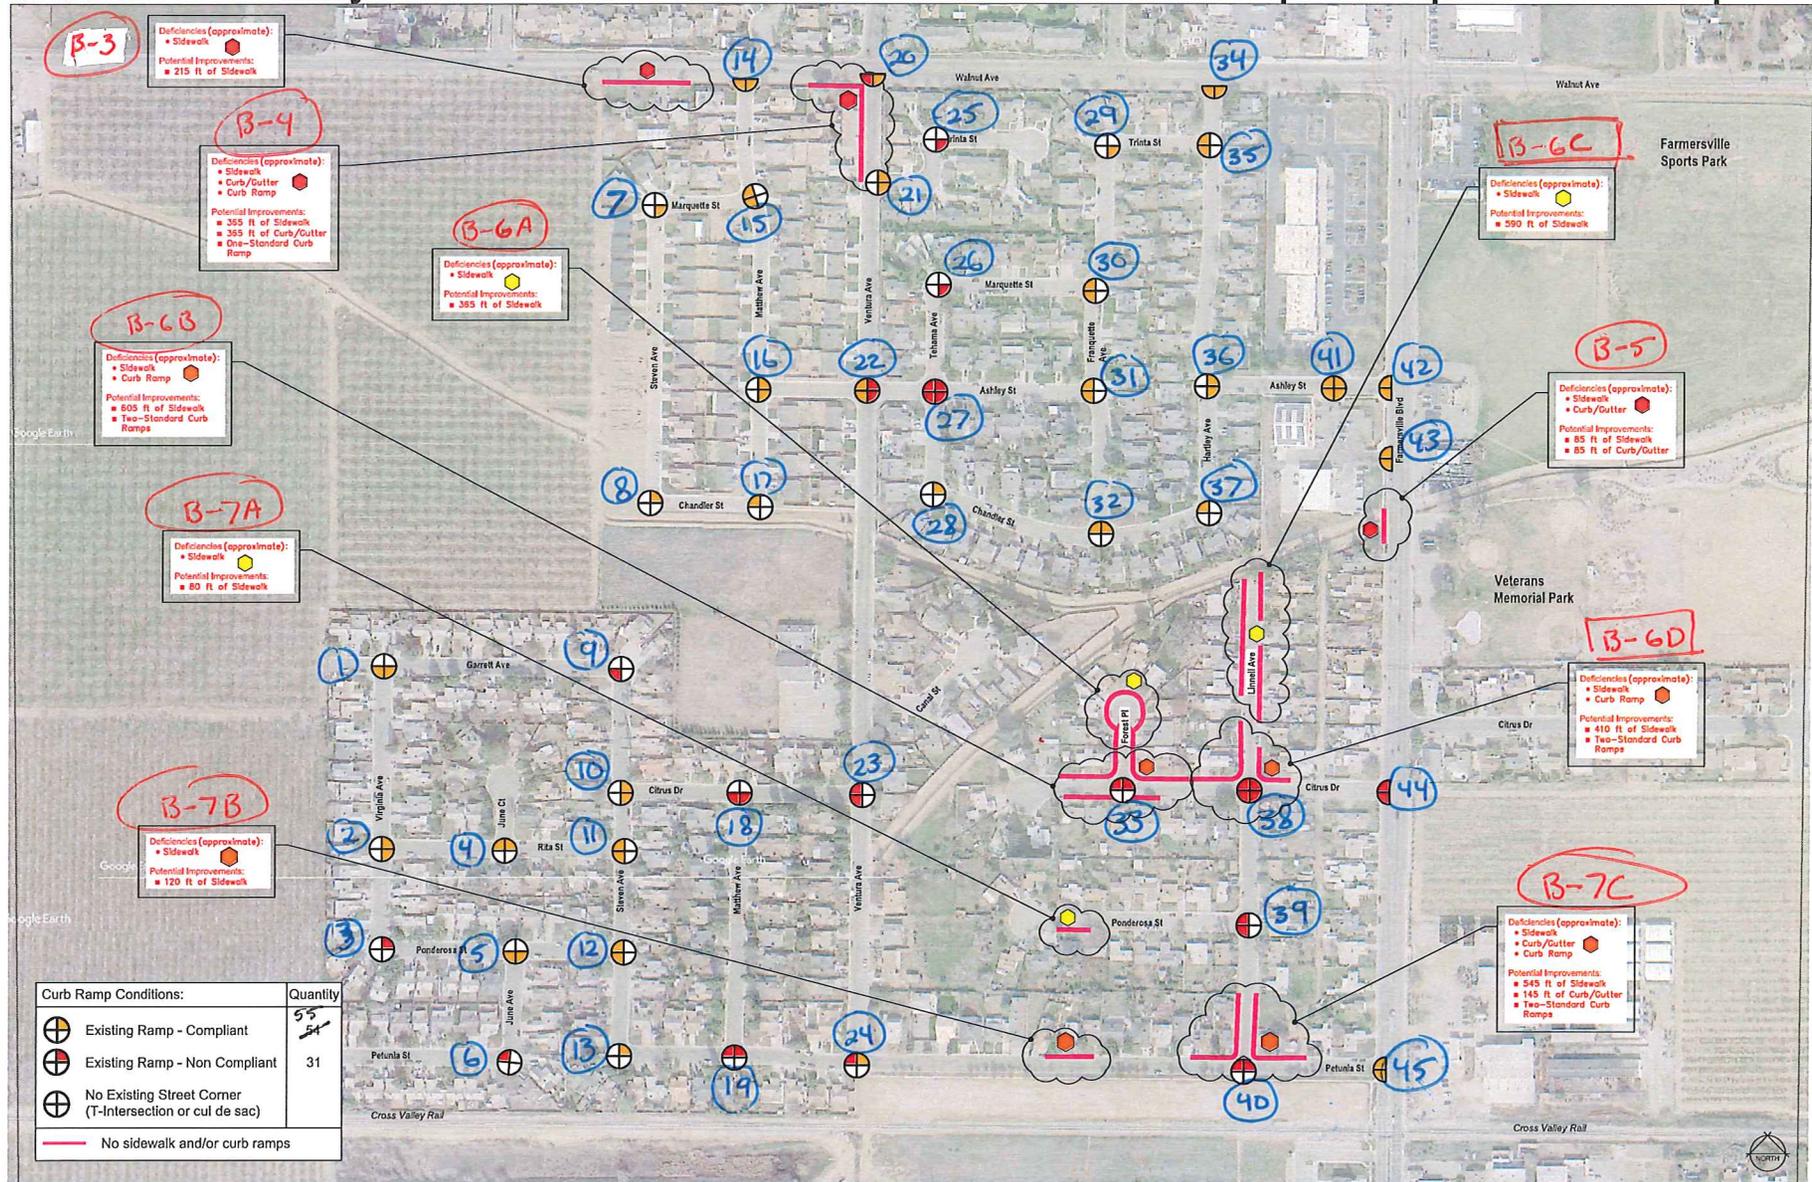
Curb Ramps: Compliant/Non-Compliant

Curb Ramp Conditions:	Quantity
⊕ Existing Ramp - Compliant	55
⊕ Existing Ramp - Non Compliant	31
⊕ No Existing Street Corner (T-Intersection or cul de sac)	
— No sidewalk and/or curb ramps
